This set of photographs has been annotated to provide an initial consideration of the repairs to be carried out to the former swing bridge foundations.

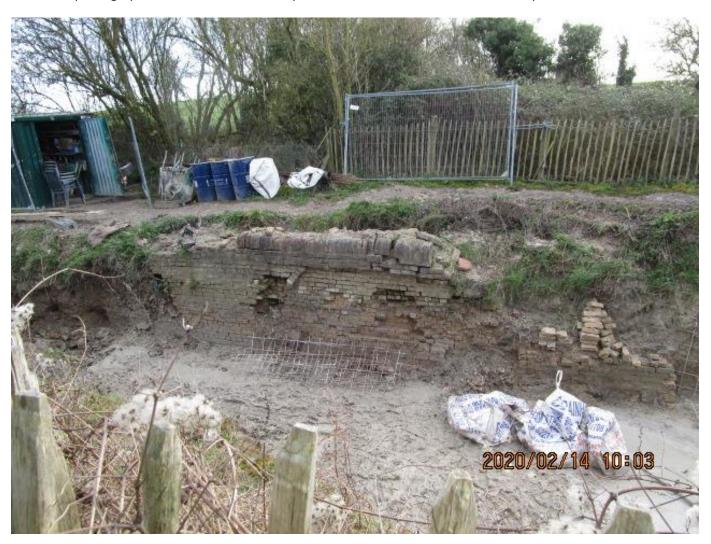
General view of the offside wall

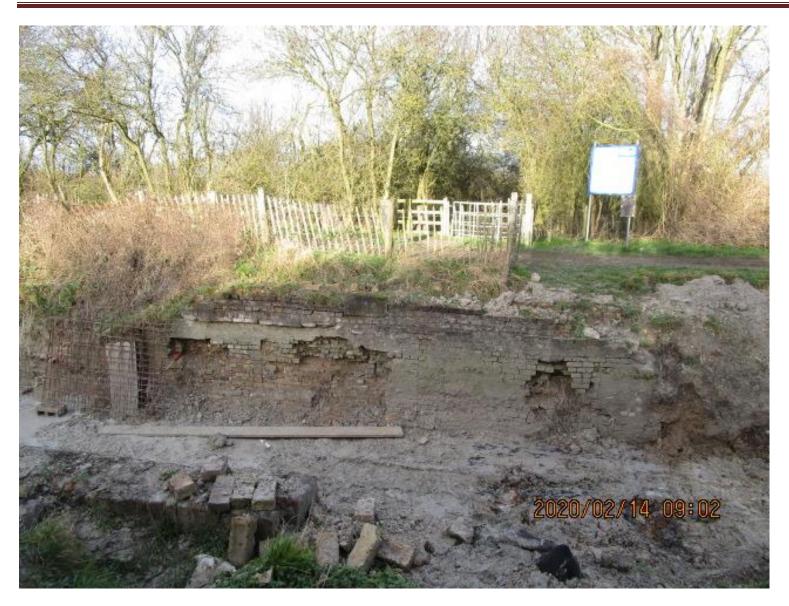
General view of the towpath wall
