# Wendover Arm Trust

## Operations Report 26 August 2021

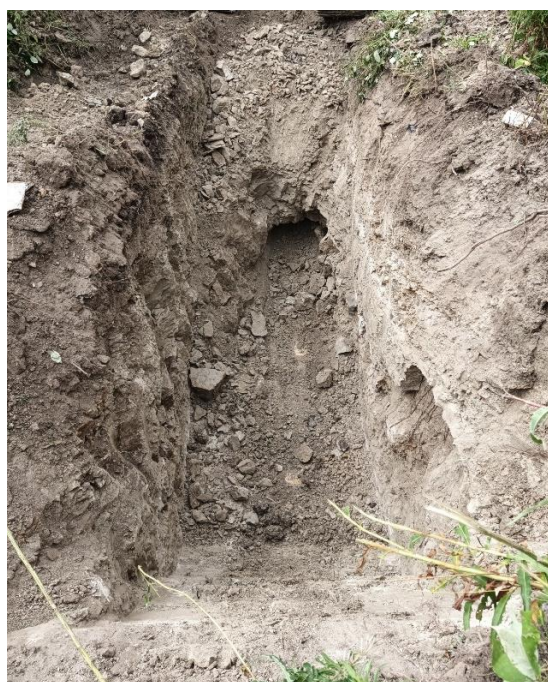
Here is what we found. What is it?

If you go back to the very first picture you may be able to see the top of the pipeline and the light brown raised mortar joints. It must have been very risky for someone to hand dig some 30 m under the rock especially as what appeared to be a softer or more easily dug layer was more likely to drop from the roof.

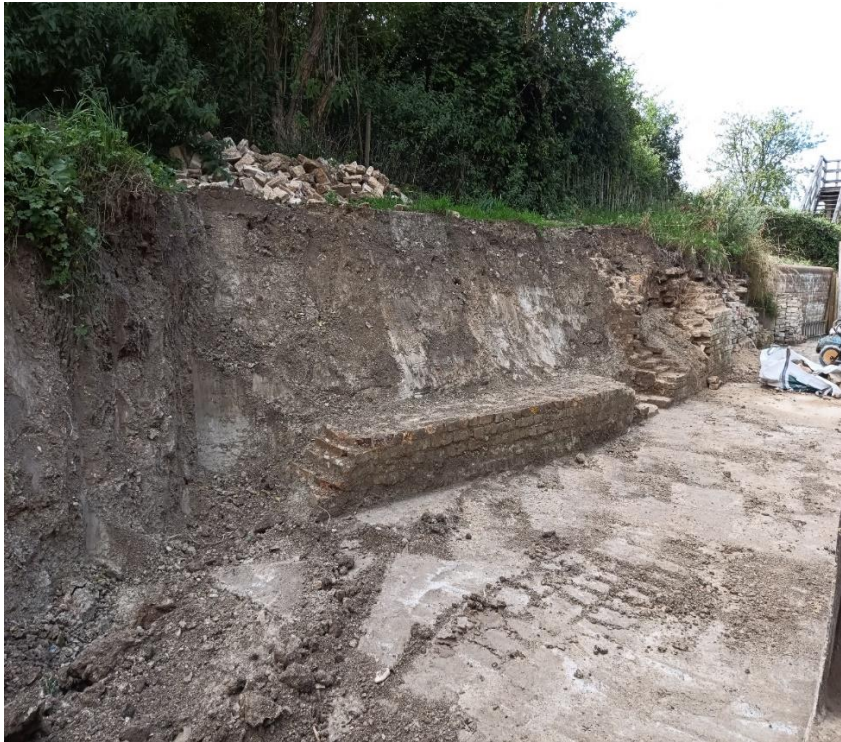
Having now finished the brick work on the towpath side, "all we have to do" is make a mirrored version on the offside. The existing structure condition was found to be very poor and most of the work done was demolishing the brick work and excavating down behind the bricks to give a clear working area. Rebuilding can now begin.

The new joining wall can just be seen towards the bridge. The remaining bricks are structurally sound. Not much left is there?

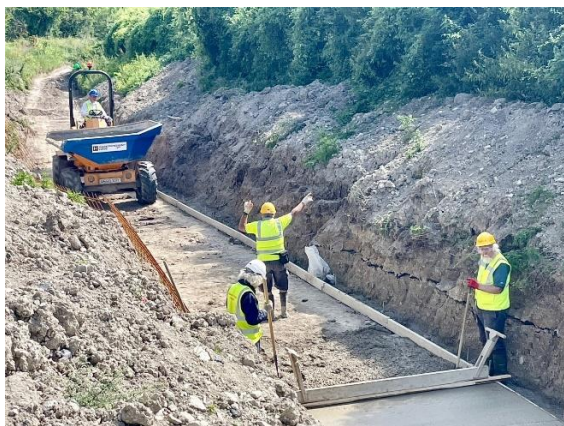
The dumper driver can't see where the former boards are and is guided with hand signals. (Or maybe he's been sent off?)

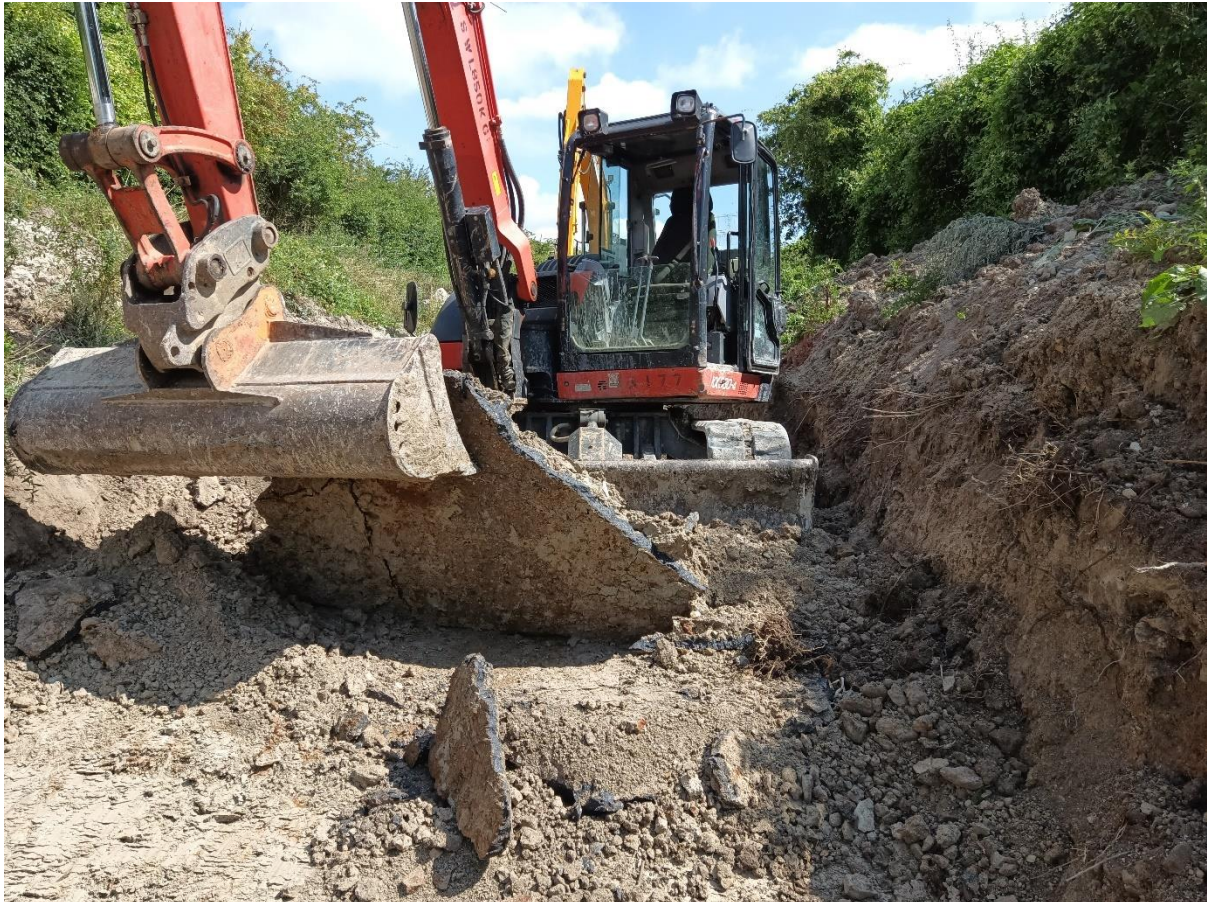
We also found that the old Coal Tar lining was intact across the bed, the coal tar being put there long before the pipeline.

The coal tar was intact and quite thick right across the bed

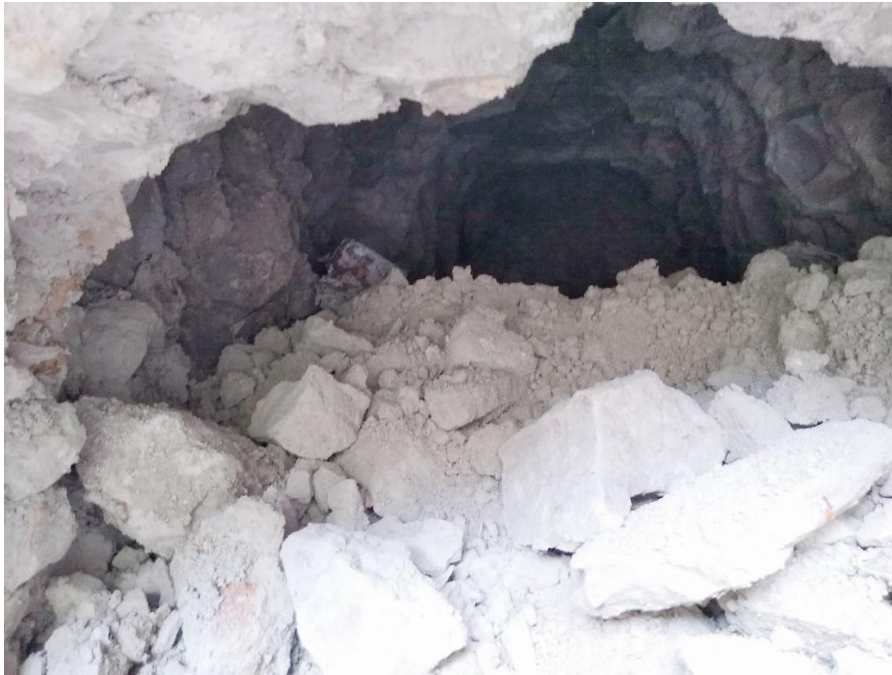
Yet more excavation showed an opening that looked like a cave entrance. But it wasn't. We found that excavating with the 13-tonne machine was difficult due to the very hard (almost like limestone) chalk layers. It would seem the team 100 years ago also found it so difficult to carve through, that they decide to tunnel under the rock!

A closeup shot of the tunnel entrance, there wasn't much room in there for the pipe and a person doing the mortar joints! (This picture was brightened to let you see further into the tunnel)

Since we now know there is no trench to follow in this section, and the Bentomat will be safe from damage due to the layer of rock forming the tunnel being some 2m thick, we decided that the pipe capping could run down the centre of the bed away from the pipe position. The hole was filled in for safety reasons.
