## **Operations Report January 2022**

### **The Tip has started to go!**

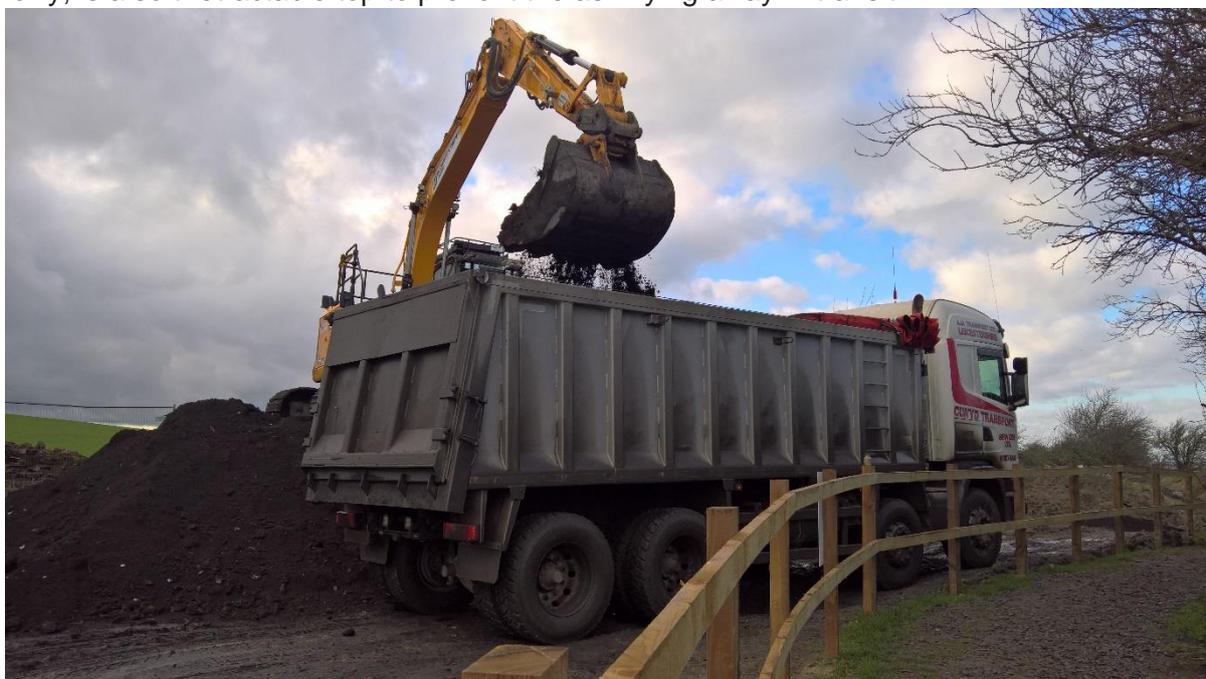
44 lorries took around 870 tonnes of material (which is about 15% of the total amount to go from the tip) to the large FCC waste disposal site at Calvert over a 4 day period. Here is a 13 tonne excavator loading ash into one of the lorries. The red on top of the front of the lorry, is a soft retractable top to prevent the ash flying away in transit.

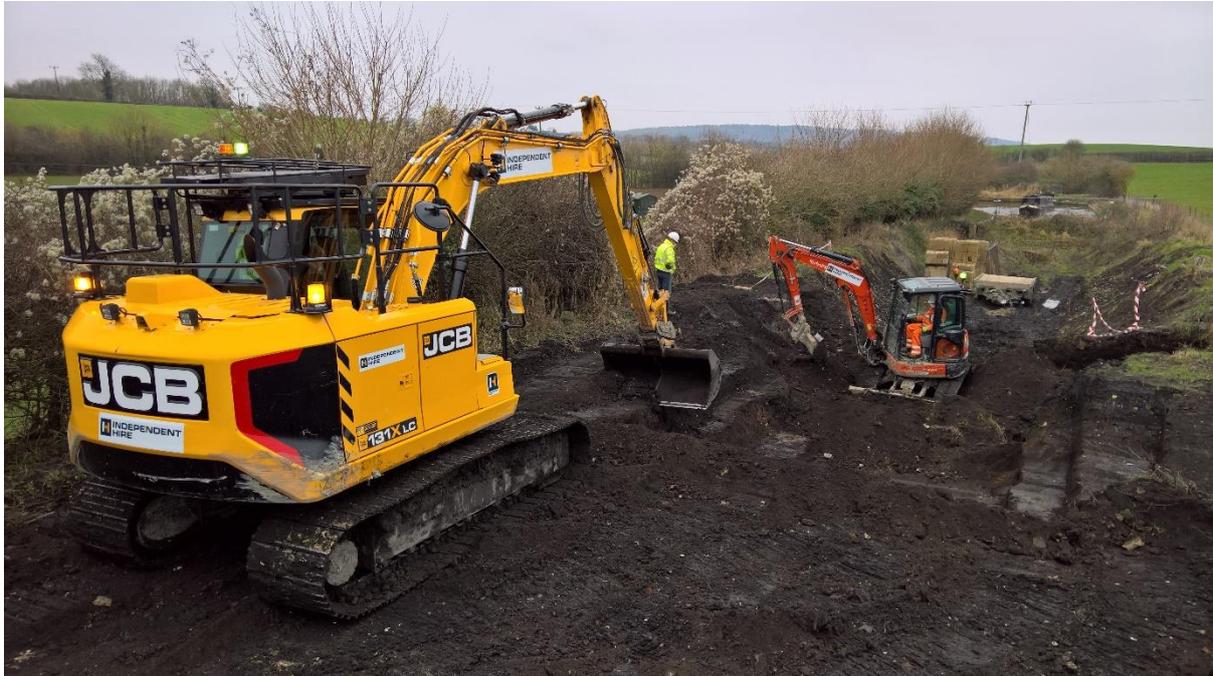
The above picture shows ash being dug out. In the background is a narrow boat “winding” (turning) at the current head of navigation (which we opened in 2005). The ash is about to be loaded into a dumper and taken to the pile shown on the previous page for removal. At the end of the working party, all the ash previously piled up at this location near the winding hole had gone, and most of the ash on which that pile was standing, has also been dug out.

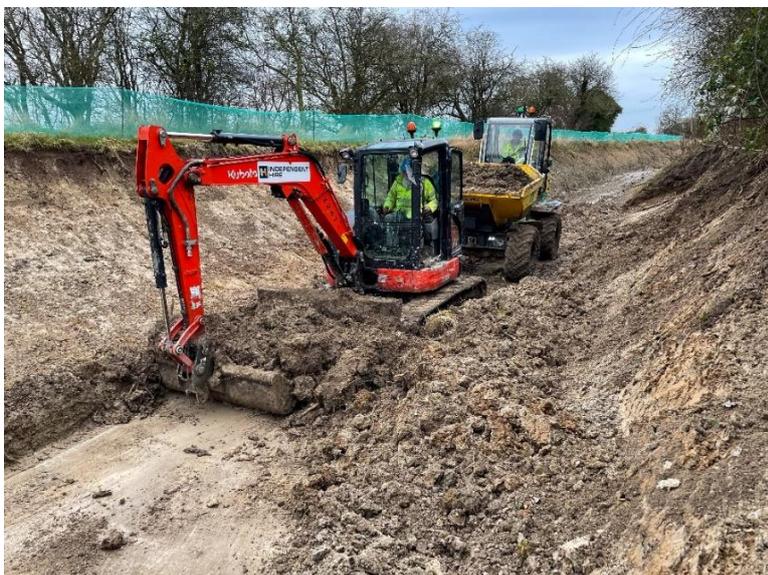
Although no relining took place this month, some “profiling” was done (excavation of the canal to the required shape ready for relining) and we covered most of the remaining previously-laid lining with spoil.

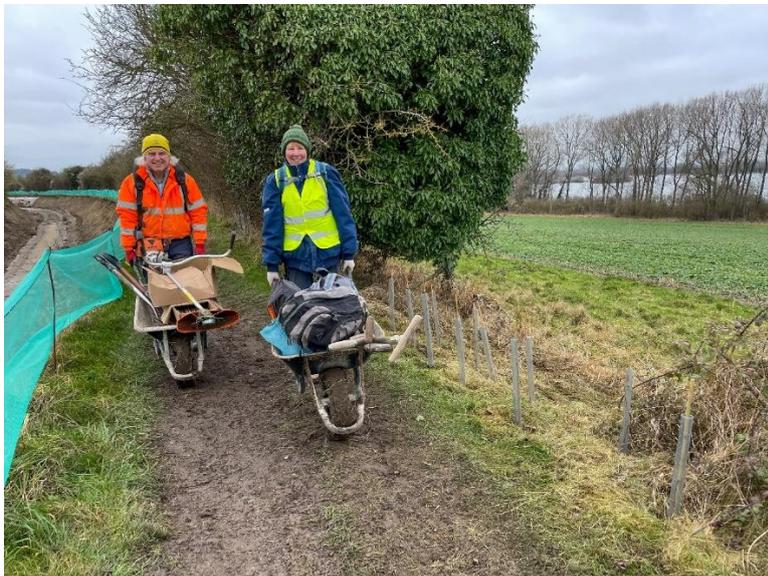
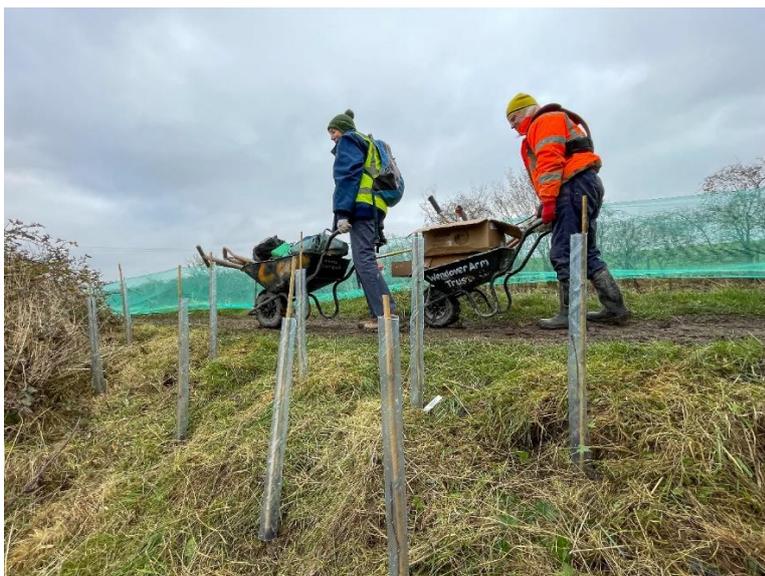
The last 150 trees were planted along the towpath, to fill in any open hedging – note the newly planted trees in both pictures below, on the towpath bank. This winter, 560 hedging and trees have been planted by WCT volunteers and Aston Clinton Scouts, all supplied by the Woodland Trust.
