Operations report for June 2019

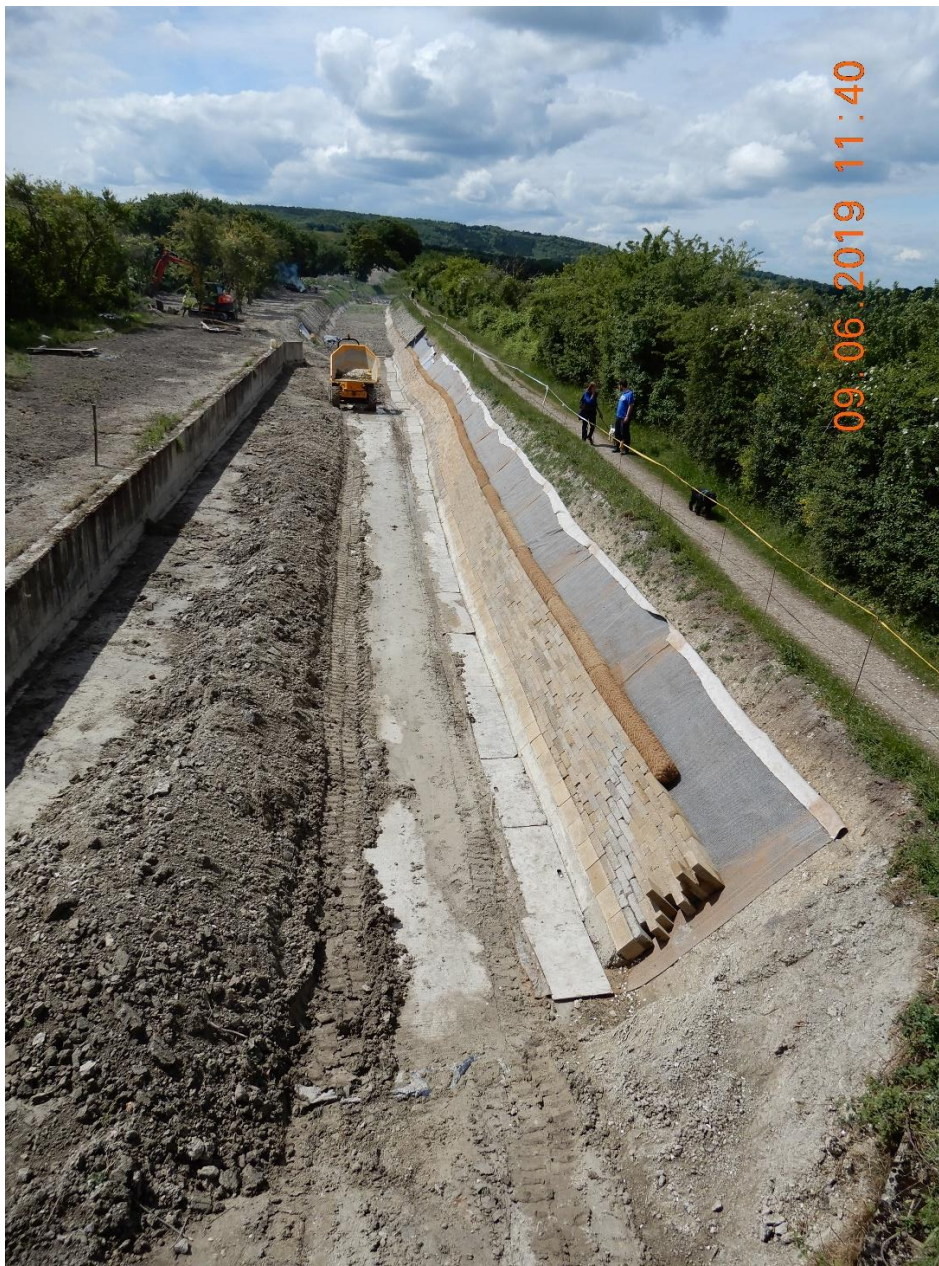
The view from Bridge 4 (several views this month)

The main thing to note is that the lining is now right up to bridge 4.

Despite storm Miguel the spoil available to back fill the banks was far too dry to allow it to be placed to the correct thickness. However later in the week we had lashings of wind and rain but too late to help us. The exposed Bentomat will withstand some weathering and we will cover it up next month.

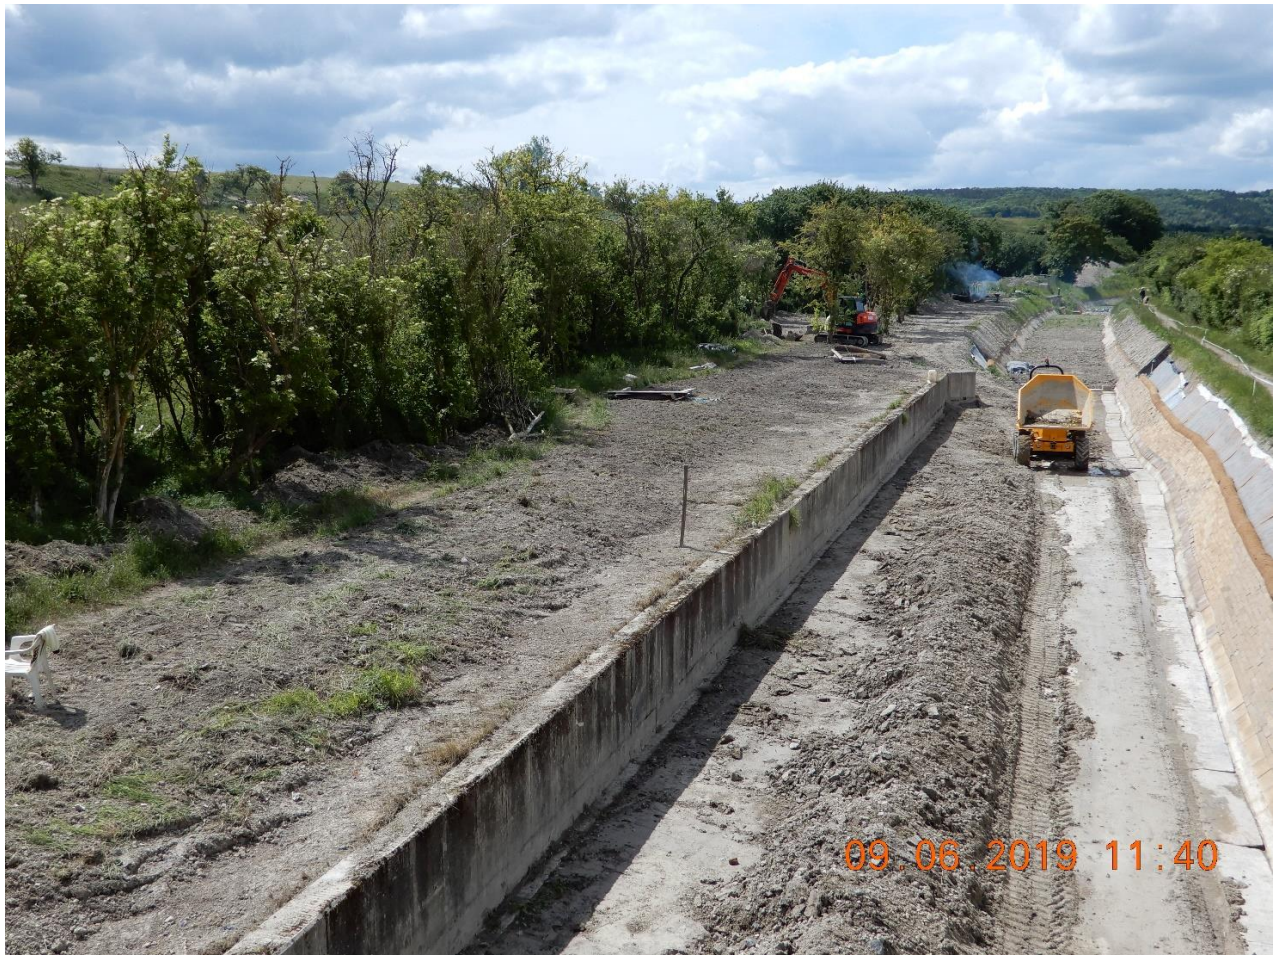
As can be seen in this picture and the next is that the lower edge of the mooring wall has now been exposed ready for the bed lining to be laid and blocks put on to the mat. The line of spoil that can be seen was placed there for next time in the hope that it will have soaked up the “right” amount of moisture so that we can use it to backfill the bank.

In this view the soil on top of the mooring wall has been scraped back and levelled to start creating a grassed area. Most of the scrub and dead wood has been removed. The remaining desirable trees have been reduced in height and “pollarded”. New trees have been planted and lots more are due in the Autumn.

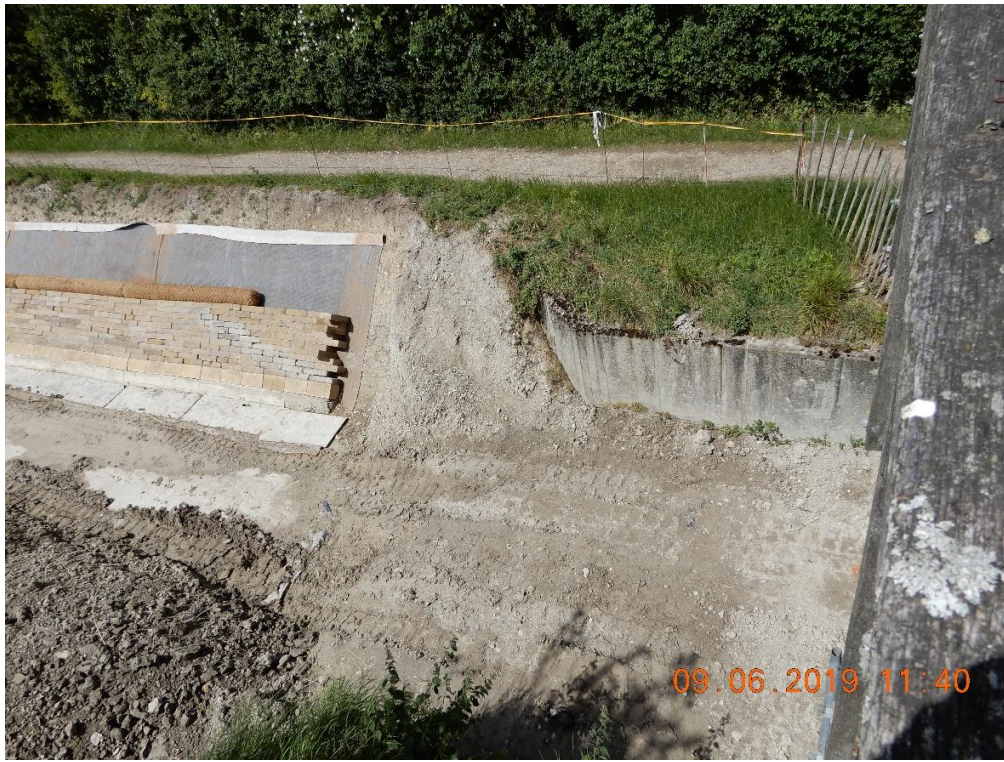
The point where the towpath lining has been stopped is where several features meet up. There will be concrete, and block work to connect with the pipe capping, the bridge bed and the bank lining blocks. The Bentomat will be tailored round the various features as we go.

The view above shows the end of the bridge support wall (abutment) and the lining so far.

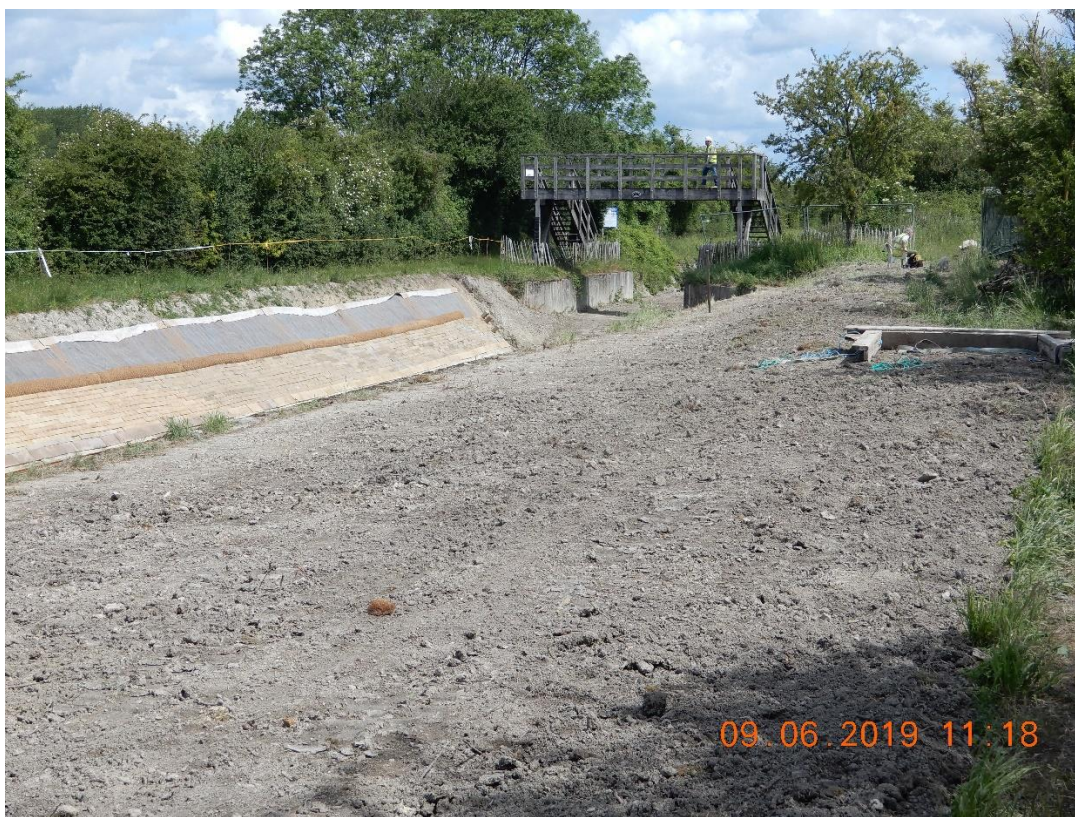
Another view from the top of the mooring wall

Work continued on the whole area, stretching from the mooring wall right back to the Whitehouses compound. The previous pictures show the extent of the works. Also, as can be seen in the view above, that hard work has now created the start of a grassy picnic/mooring area.
