# THE WENDOVER ARM TRUST WORKING PARTY NEWS

ISSUE 113

February 2016

## January and February Working Parties

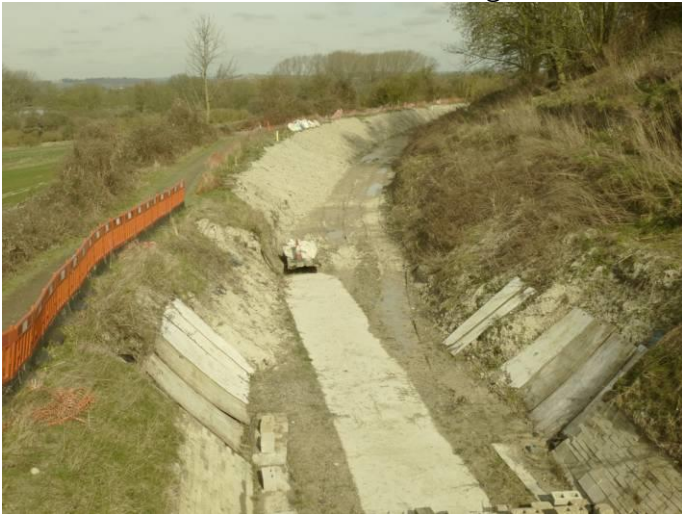
During these working parties only bulk excavation was possible and even this was curtailed by the bad weather. Nevertheless pipe capping, bulk excavation and rough profiling of the banks is mainly complete to within 100 metres of the end of Stage 3.

The above picture, taken from Bridge 4A, shows the completion of pipe capping and rough profiling of banks that extends towards Whitehouses and the picture below shows the completed pipe capping that is being covered with spoil and approaching the end of Stage 3 at Whitehouses.

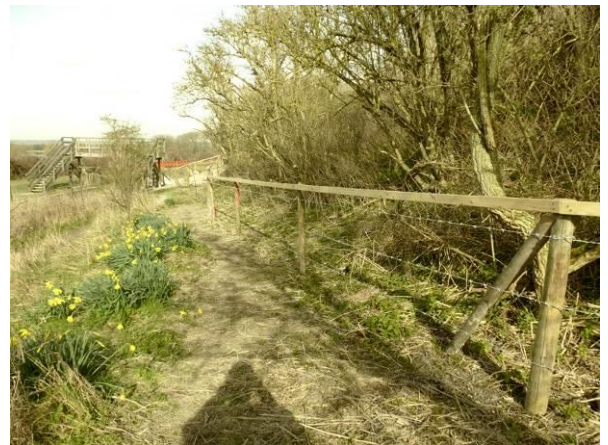
At Bridge 4A a new fence has been erected by the public footpath leading to the bridge and the area generally tidied up. Note the daffodils that, to my recollection, have been on this spot for many years.

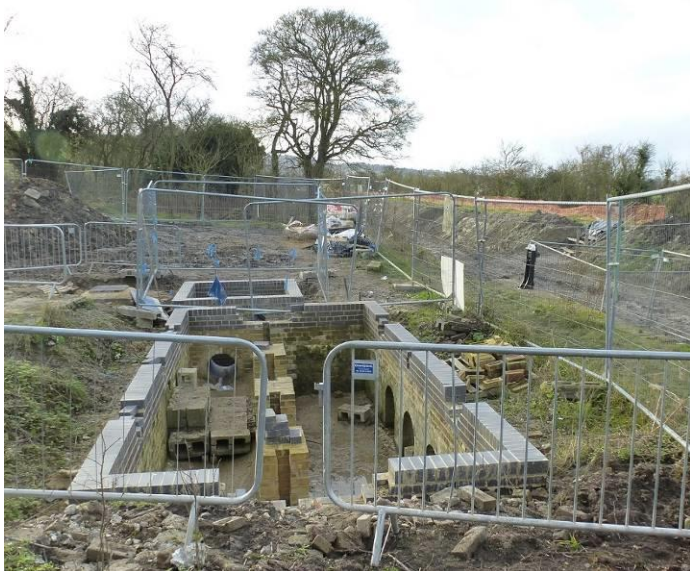
The good work to the old settling tank by KESCRG that was illustrated in the last issue of this newsletter as below has now been covered by CRT with a galvanised steel grid as a safety measure as shown in the second picture below although the public will be able to view what is going on underneath.

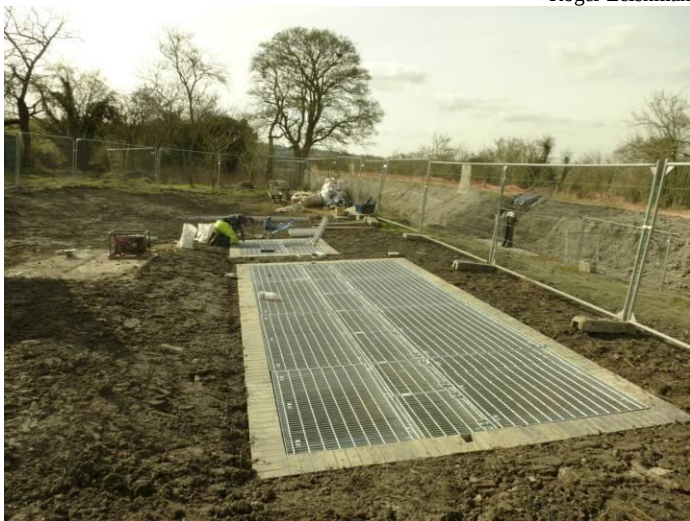
Beyond the main grid you can see the CRT contractor putting the finishing touches to the grid over the new manhole.

Once re-watering is complete up to Tring Summit level the adjustable weir that you can see in the former settling tank will take water from the canal through the three short culverts through the wharf wall into the right hand side of the weir.

Once the desired water level has been reached, any surplus water from Wendover will weir into the left hand side of the settling tank and flow into the culvert that you can see in the back left hand corner into the new manhole and, provided the sluice in the manhole is open, drop down the former pumping shaft into Wilstone Reservoir. The former pumping shaft is now accessed by a cast iron manhole cover just to the left of the new manhole.

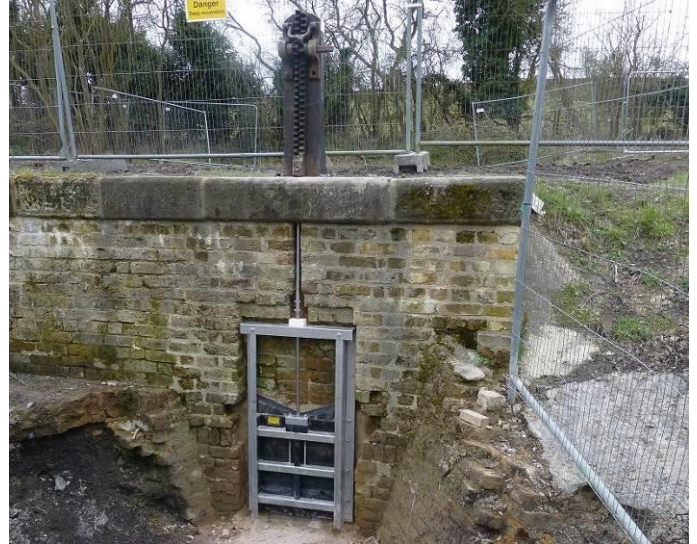
When KESCRG reinstated the coping stones on the wharf wall care was taken to position the hole and four holding down bolts in one stone so that it lined up with the groove in the wharf wall where a paddle had been situated until it was moved to the manhole (under the concrete slab in the foreground) to act as a control to allow water from the 18" pipeline to drop down the former pumping shaft into Wilstone Reservoir. CRT has now moved it back to its original position and purpose including a new sluice gate as shown in the picture above. Once restoration is complete this outlet into the former pumping shaft will allow the pound from stop planks at Drayton Beauchamp Bridge to stop planks at Bridge 4 to be completely drained and the water will not be lost to the canal as it will drop into Wilstone Reservoir.

A new manhole has been constructed on the site of the prunus tree that had to be removed because the roots were damaging the brickwork of the settling tank and in the way of this new manhole. This manhole contains sluices to control water from Wendover into the former pumping shaft.

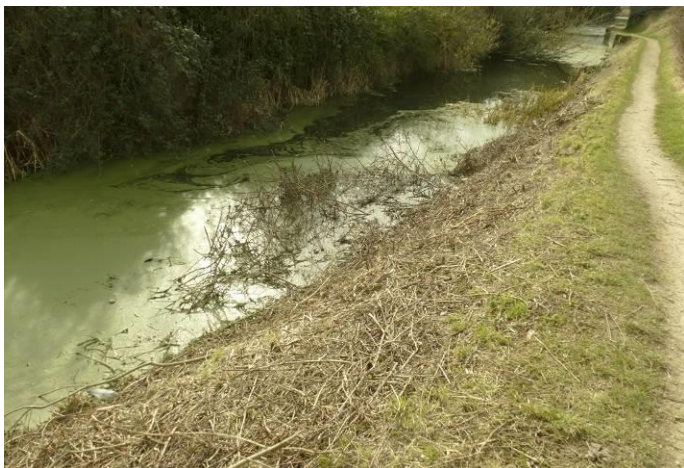
My other concern was the growth of saplings, mainly ash, between the towpath and the water's edge. CRT's contractor has now cut these down but unfortunately left all the debris on the bank and in the water. I also noted this week that the contractor has cut the towpath bank along Stage 1 and, again, left all the debris either on the bank or in the water.

**A GOOD WAY TO BLOCK THE FLOW OF  
WATER AGAIN!**
