## Operations Report

Website: - <http://wendoverarmtrust.co.uk/>

#### **New walls at Bridge 4.**

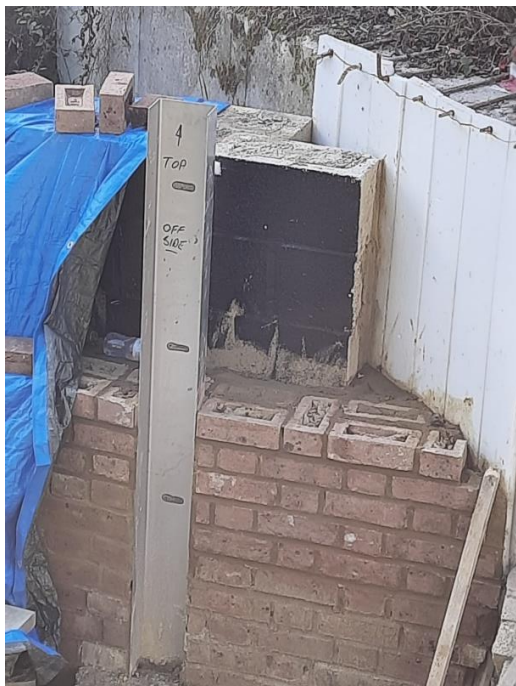
Here is the offside brick work being built up around the stainless-steel stop plank channel.

The white material is the expansion joint between the new wall and Bridge 4 abutments.

The block work was completed and each of the hollow block "holes" had a reinforcing rod inserted then filled with concrete. A layer of waterproofing was added to the block surfaces. The brick work on the offside was started (this incorporates the stop plank channels) and is now around 2/3 built.

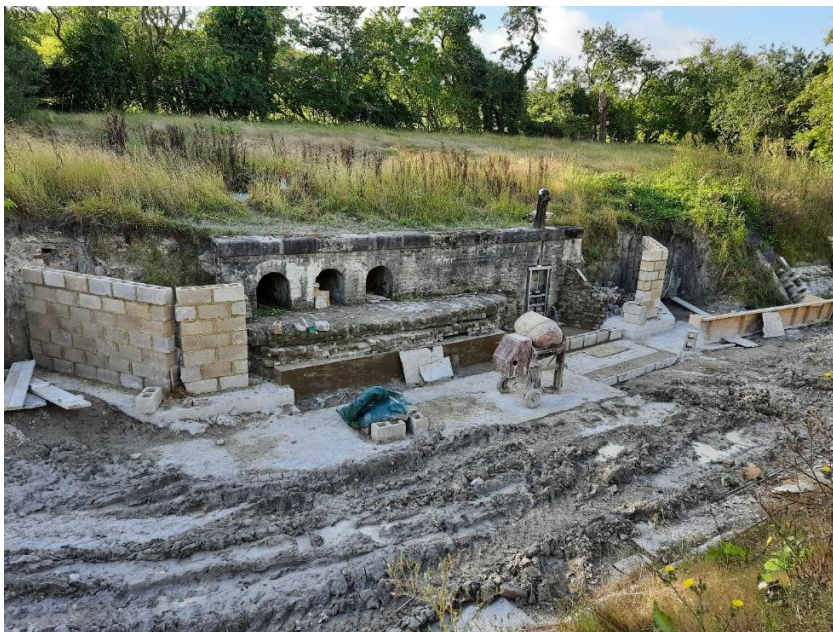
Whitehouses showing completed foundations and block work.

The concrete mixer is on the new pipe capping extension. Just next to that are the beams covering the manhole entrance.

**At Whitehouses**, the existing pipe capping was extended with reinforced ready-mix concrete to reach the manhole. Each end of the capping has a step down to accommodate the concrete beams that go across the manhole.

The area for the new wing wall foundations was excavated, levelled, had form work made up and the concreting was completed by using ready mixed concrete. (in pouring rain!) Following on from that, form work was built up to enable the “front apron” support concreting to be completed.

Following on from the wing wall foundations being laid, the block work was started and completed over the course of the work party.

The manhole was uncovered, and the top layers of the chamber bricks removed to the required height. Concrete floor beams and solid concrete blocks were used to cover the manhole. More concrete was applied on both sides to limit the beams’ sideways movement. It will be possible to lift the beams for access to the manhole until the Bentomat is laid over the whole area. Longer term it will be possible to identify the manhole position and get access for any maintenance that may be required.
