# Wendover Arm Trust

## Operations Report 24th December 2020

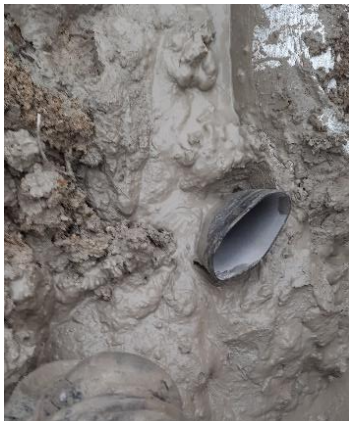
This picture sums up the conditions we were working under. This can be funny for observers but is not fun if you cannot get your foot or boot out and a vehicle is approaching. Whose boot is this?

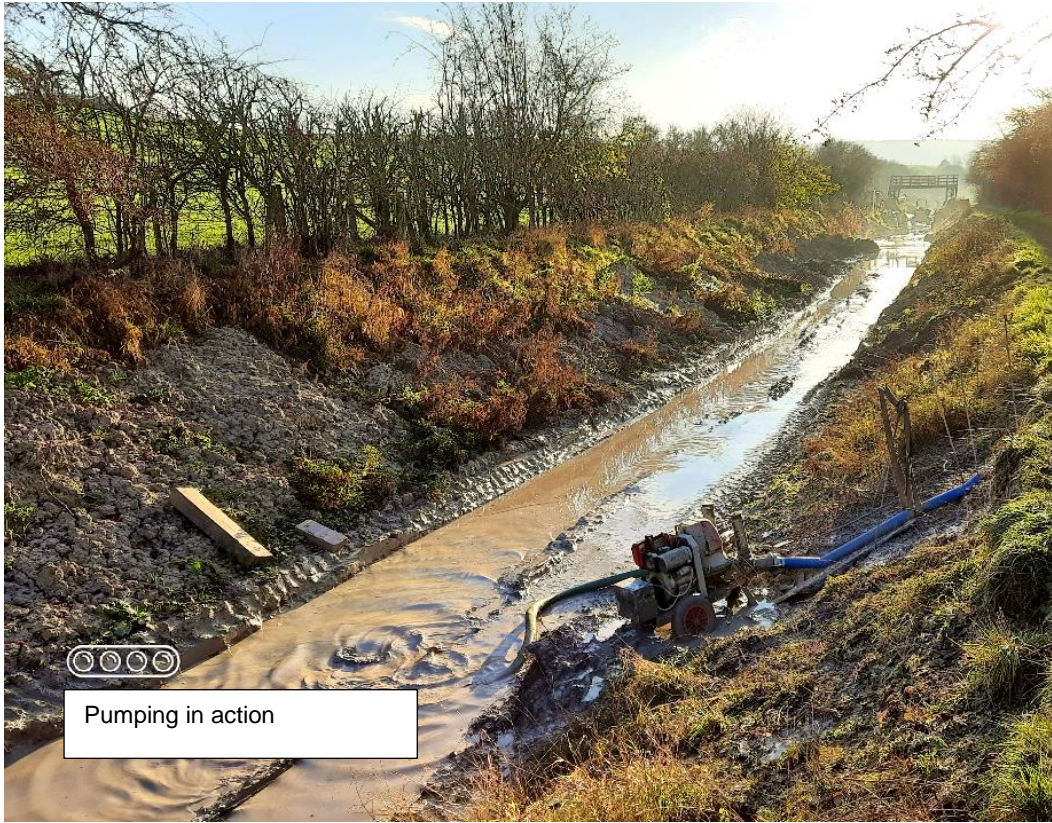
The combination of large amounts of rain two to three months ago, and restricted working due to the C19 virus has meant a large build up of water between bridge 4 and the car park. This in turn gets churned into a slurry by the plant machines passing through. We hired a different type of pump to our normal ones and this one handled the mixture of slurry and vegetation quite well.

We pumped water and slurry for most of the work party to create a dryish area between the old Swing bridge walls. In addition, several earth bunds were created to control the water.

As can be seen later the flooding caused several problems.

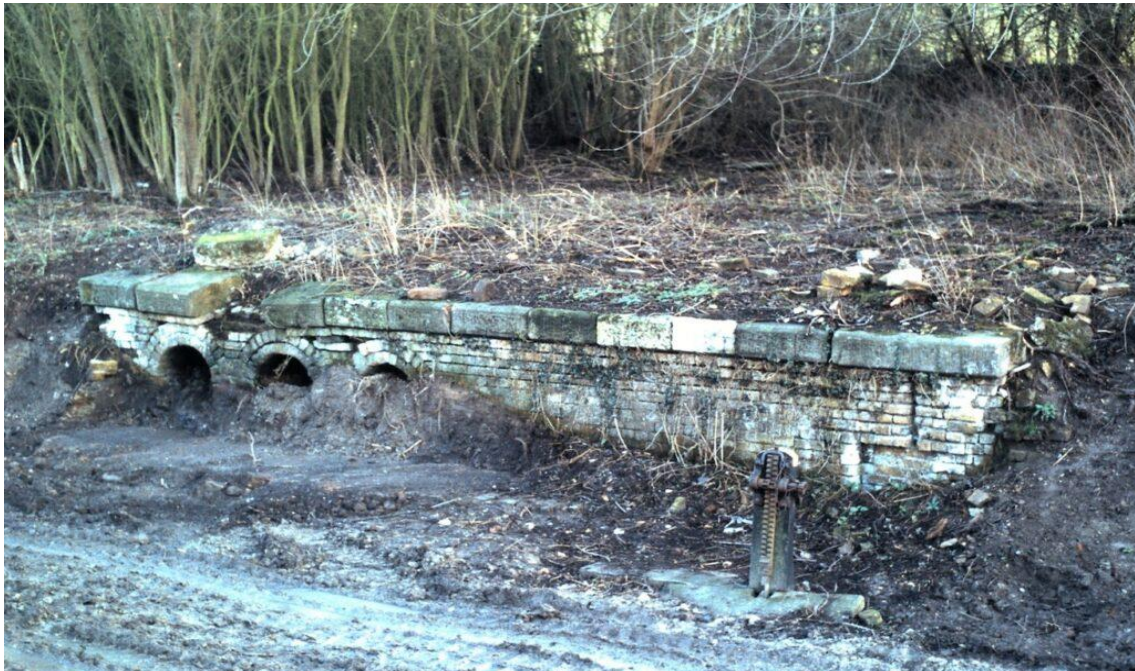
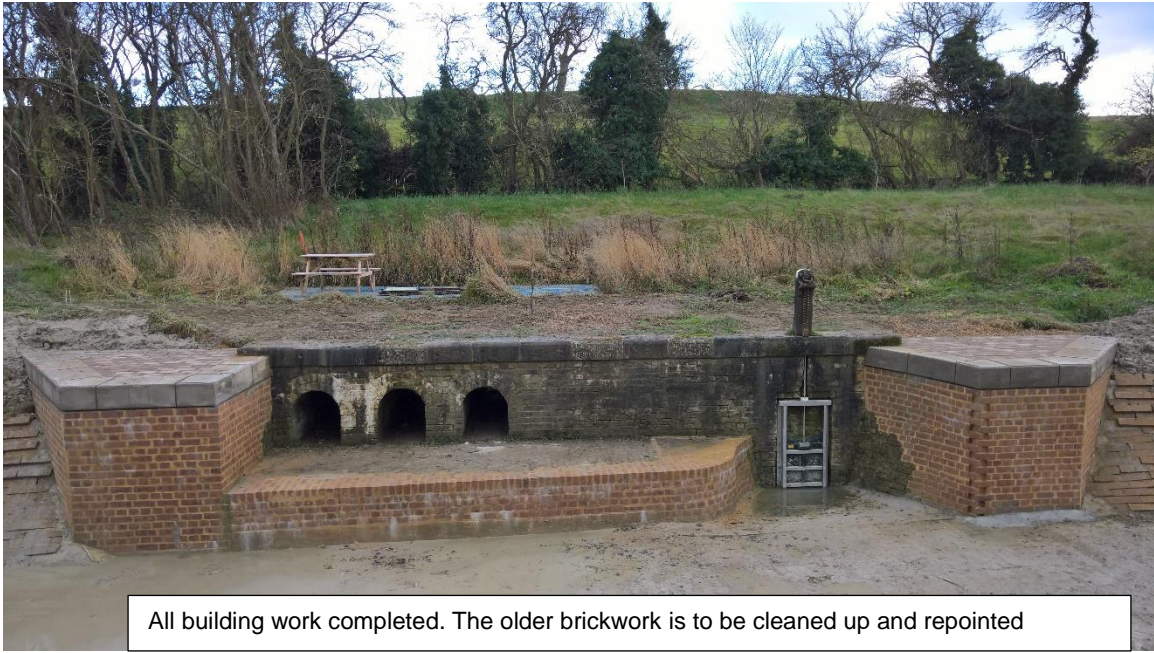
## Whitehouses

Before and after pictures. (Guess which is which!)

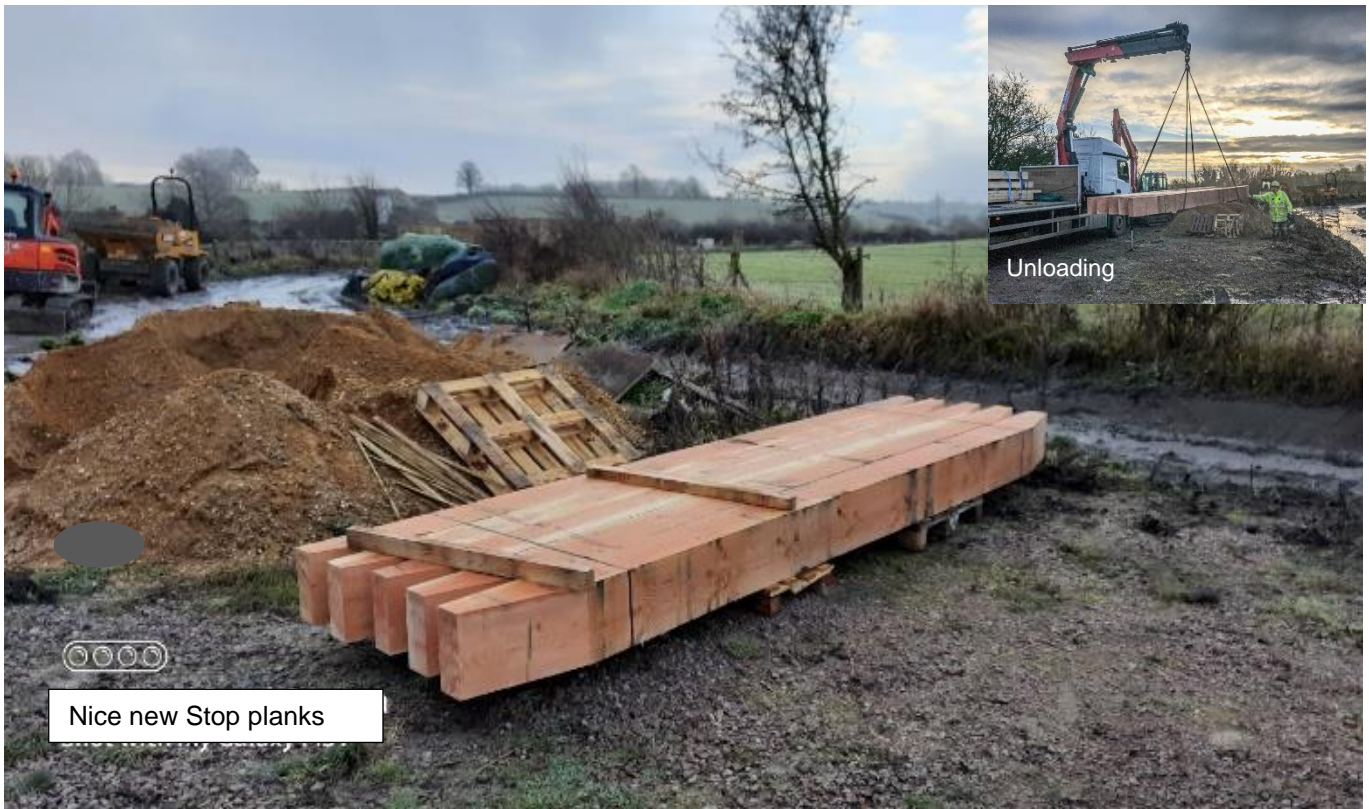
### Bridge 4 Stop planks

These planks were designed using the standard CRT calculations and they have been made specifically fit the stop plank channels in the Bridge 4 new walls. Further work will be needed to ensure that they fit the channels correctly.

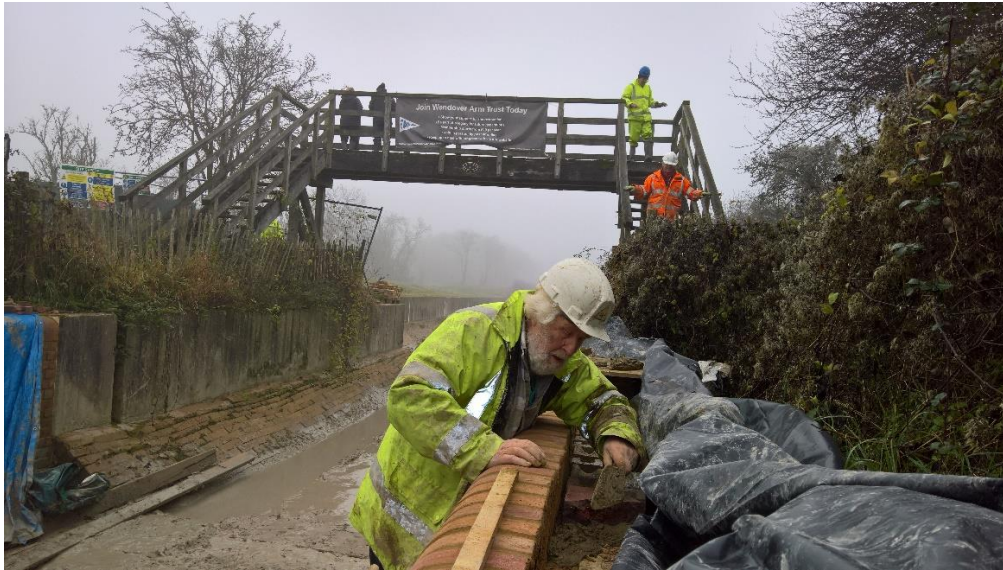
And this is where the stop planks will fit.

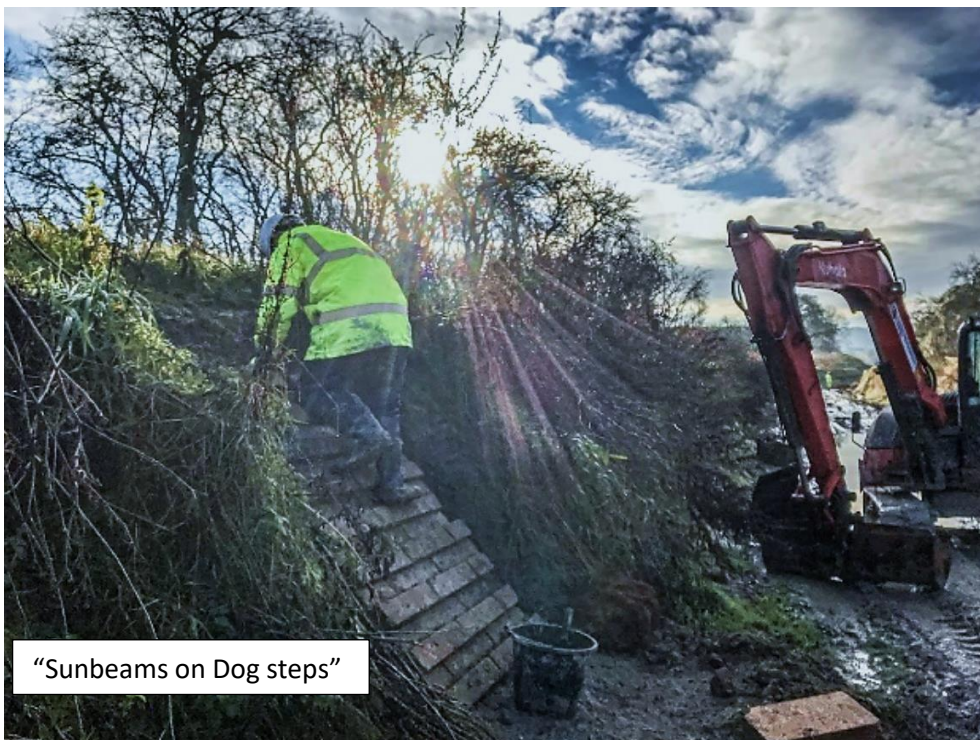
“Sunbeams on Dog steps”

We have had a constant problem with dogs and other animals getting into the water filled section of the canal at a mooring wall or similar vertical structure, and then struggling up the next available soil surface to get themselves out. This has caused erosion of the bank down to the Bentomat layer. The repairs to the damage in the “wet” section will be done when better weather comes along. In the meantime, we have decided to build these simple block structures at the end of the walls and bridge abutments to alleviate the problem.

Additionally, during recent environmental surveys, it was recognised in the restored but dry section that there were several animal tracks that ran down one bank, across the bed, and up the other bank. We have made more “animal access” steps at these points.

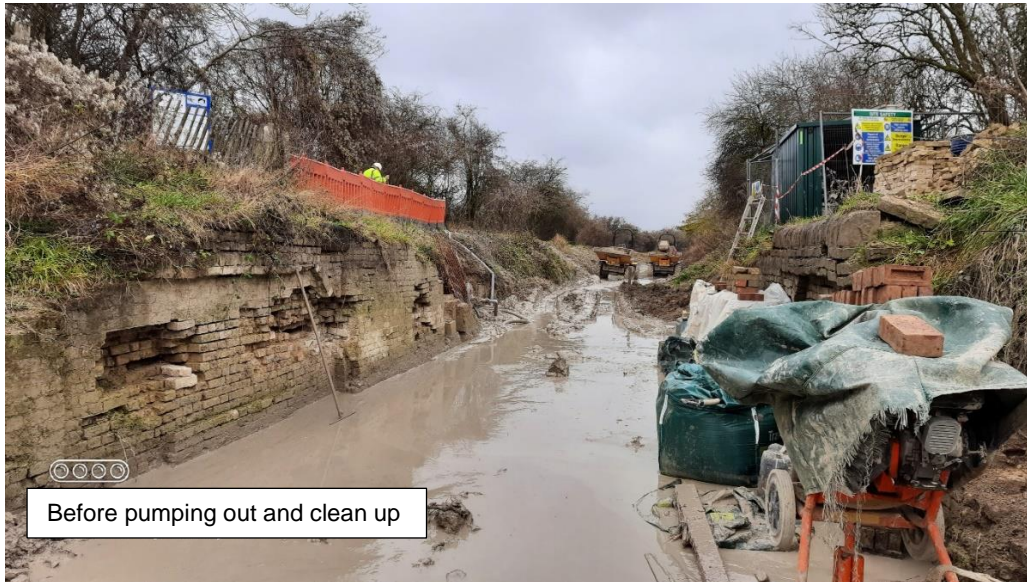
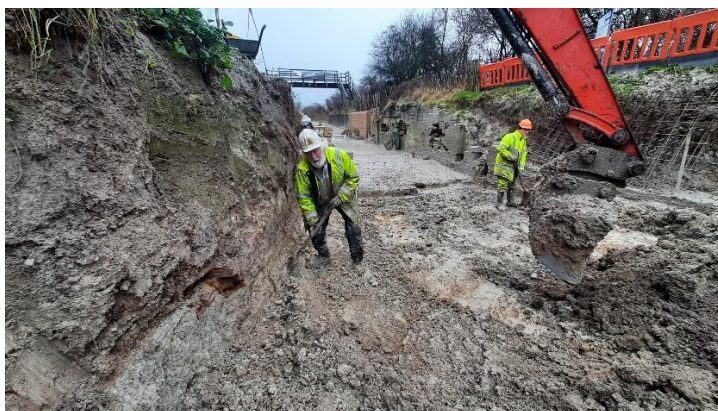
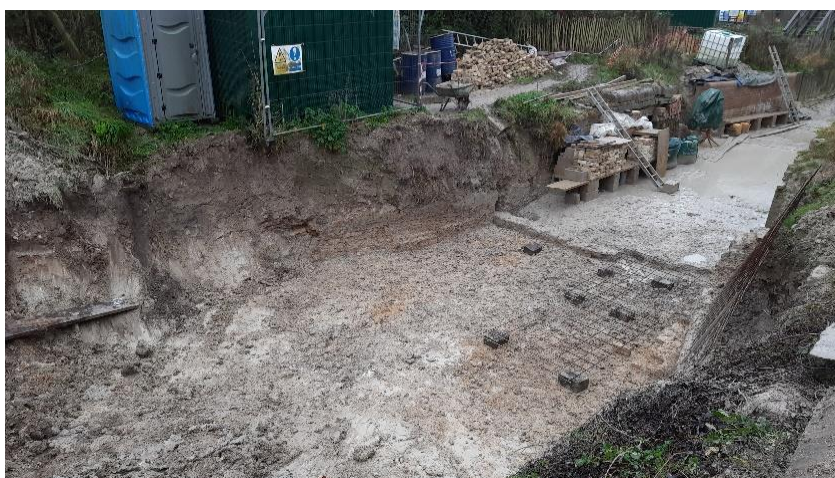
## Concreting at Bridge 4

The task was to cast 300 mm thick reinforced concrete (2 x 4 cubic m of concrete) between the newly discovered lengths of swing bridge wall foundations. The excess rainwater and mud had to be pumped out and the bed cleaned up with an excavator and by hand.

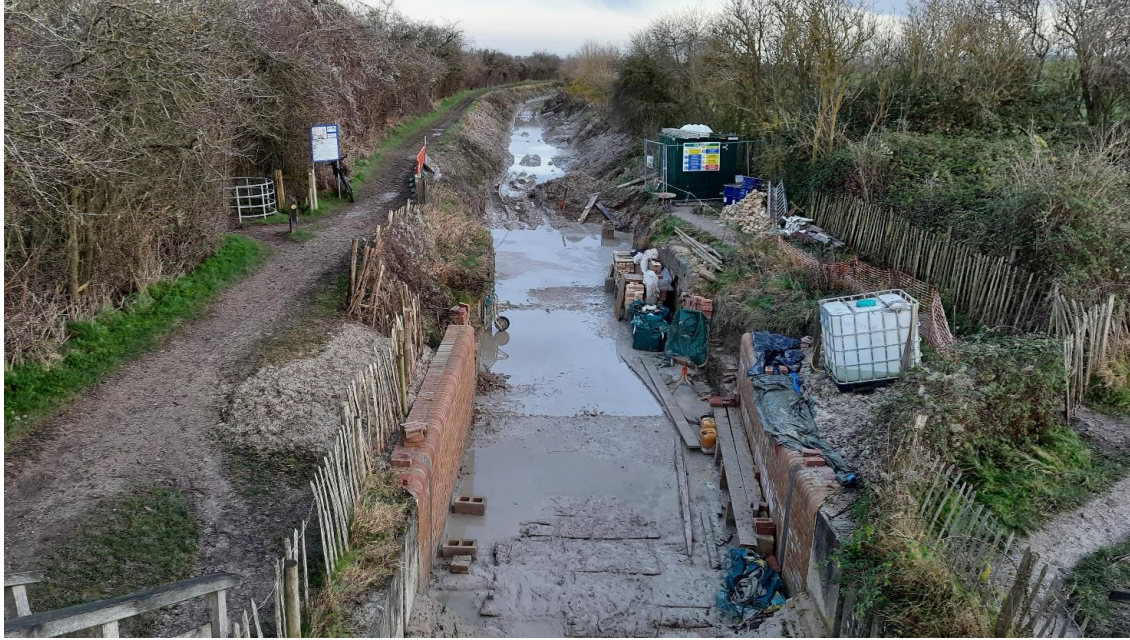
All was ready for concreting on Monday 14<sup>th</sup> morning and the first concrete arrived on schedule at 10:00 at the car park 400 metres away. After a few dumper loads had been delivered it was realised that the mud/water was breaking through the series of mini bunds along the bed. Towards the end of the concrete pour this is what it looked like, with the new concrete under water! (Concrete does cure OK under water!) Must try harder next time.....
