Wendover Arm Trust

Operations Report 23 June 2021

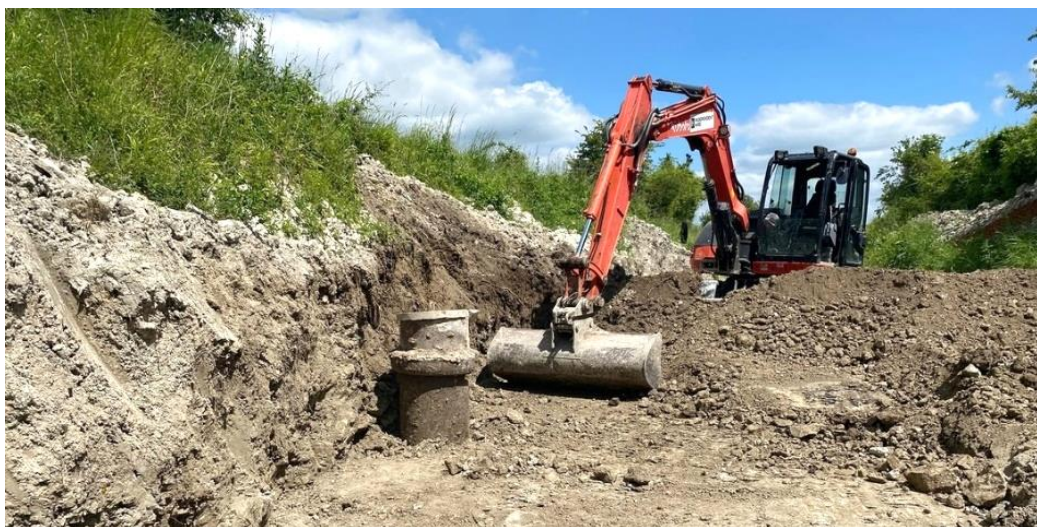
This is the top of the "lamp hole" to enable inspection of the water flow 2m down in the pipeline. To the left is the towpath.

The pipe capping/roadway has continued at a pace during the good weather. We now have 245 m of capping from bridge 4. During the recent works the second "lamp hole" into the pipeline was reached. As can be seen in the picture, the lamp hole is close to the towpath because of the glazed clay piping being laid in straight lines. The next section of pipe goes off at a different angle to "graze" the offside apex of the next bend to the right. The lamp hole pipe was cut down below bed level and covered with a concrete slab before the normal pipe capping concrete was installed.

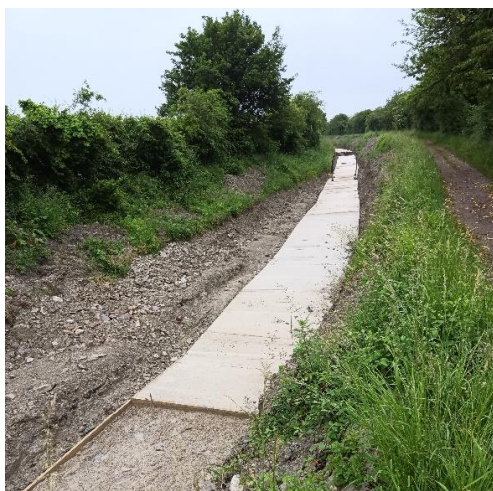
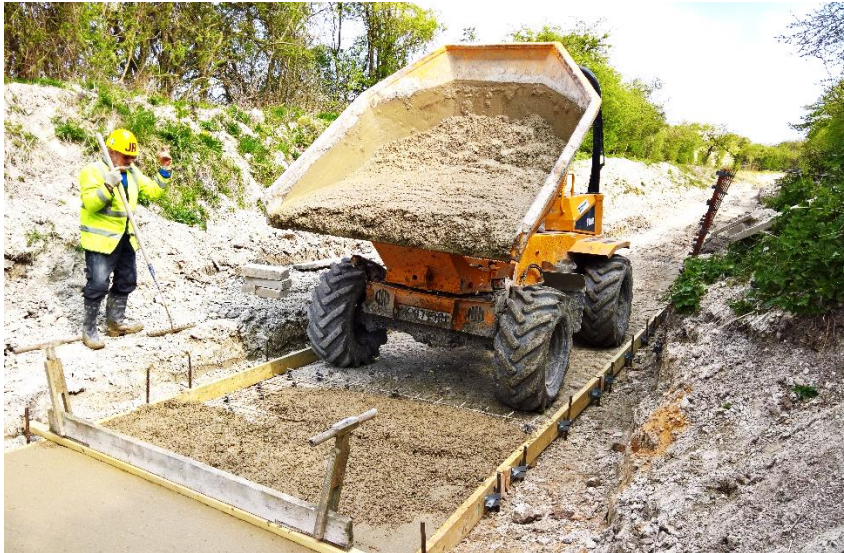
Here we are 245 m from Bridge 4 which is now not visible round the corner

Pipe capping progress has been much improved by placing the concrete “form work” wider apart to allow dumper access. The result is also a wider “road” that will be used for subsequent excavation and lining work thus avoiding the churned mud we usually suffer from in winter.

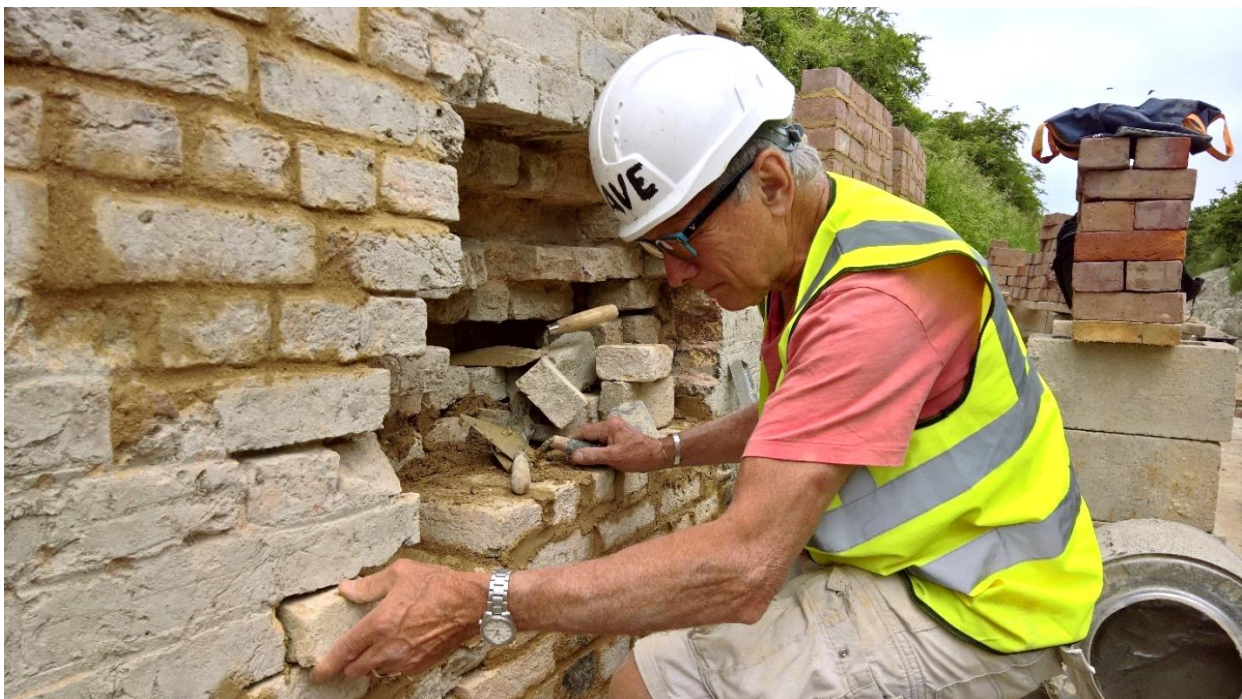
The Old Swing Bridge walls are meticulously repaired with heritage bricks and lime mortar after the loose bricks and old mortar have been removed

Work on the old Swing bridge walls has been continued. The foundations for a curved wall have now been built up with heritage bricks to form a “lead in” from the 45-degree banks to the width between the swing bridge walls. This must be robustly built to withstand boating “errors” for many years to come!

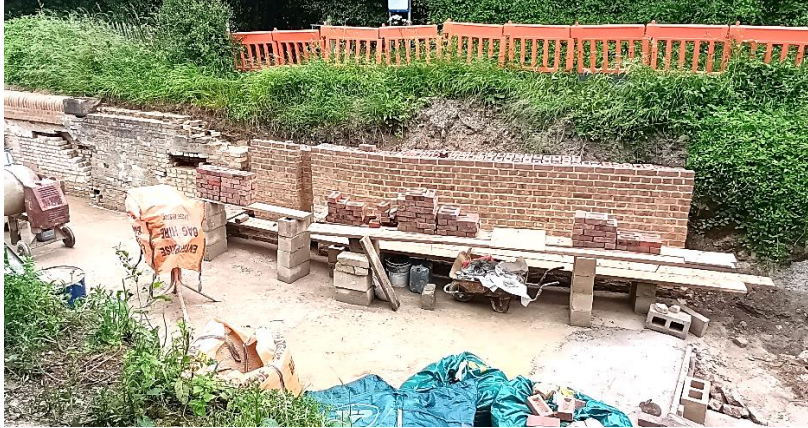
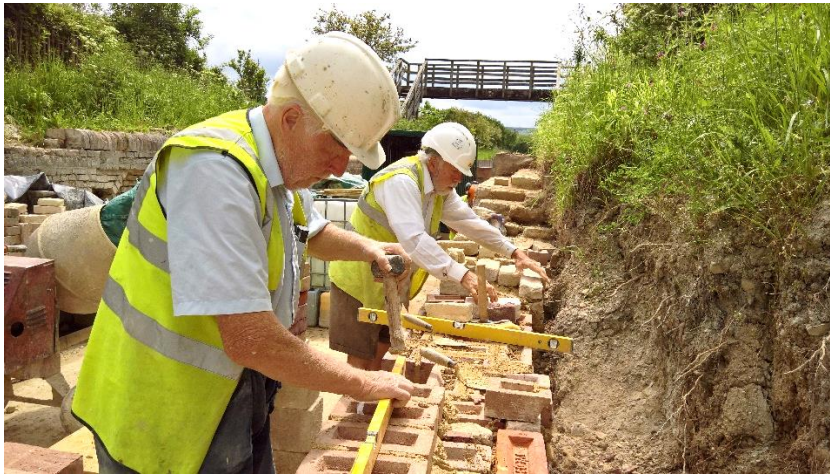
The “training” wall begins to take shape complete with stop plank recess. We will repeat this on the offside bank as well!
