## Operations Report September 2021

### Overview

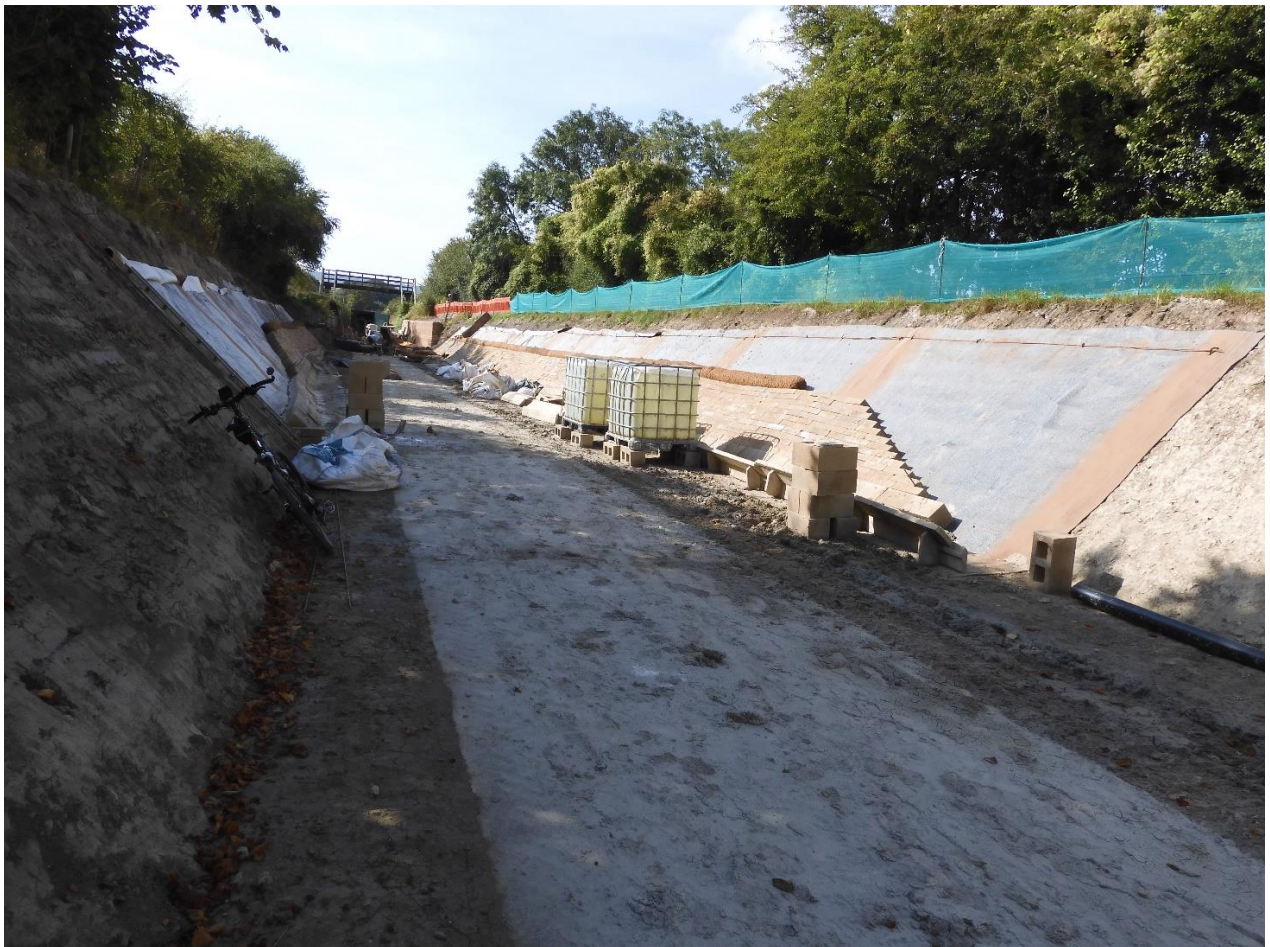
Once we were sure that we had no badgers living in the offside bank at bridge 4, work progressed to rough excavate and then final profile and line and block, both banks. As can be seen in the picture, progress along the bank was pleasingly rapid. The towpath side, at 40m long, ended up being slightly more advanced than the offside. Bridge 4 can be seen in the distance

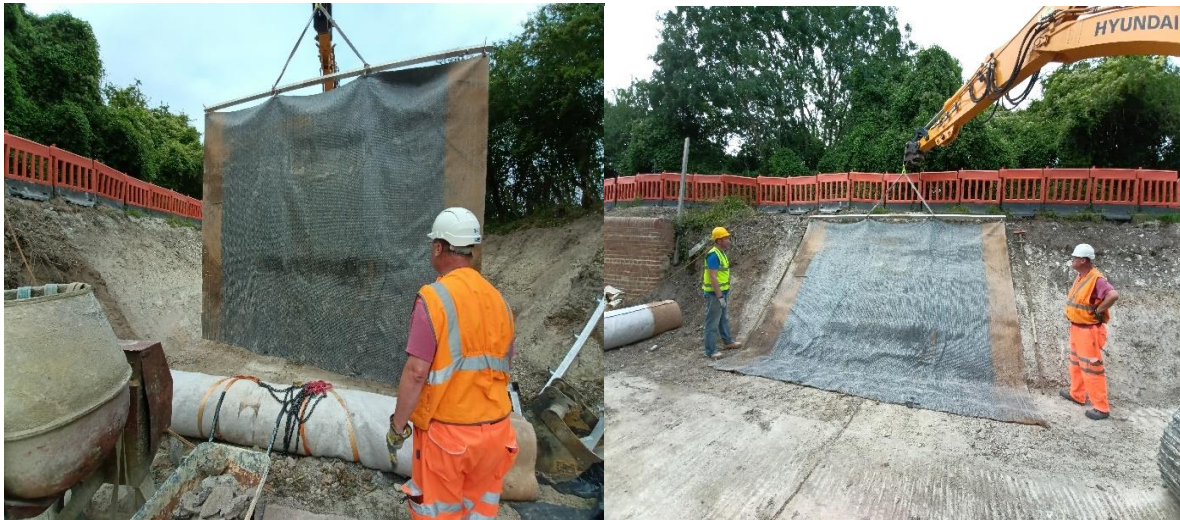
Whilst we modify the “Bentomatic”, (excavator mounted Bentomat handling rig), we needed to find an interim method of handling the heavy Bentomat sheets. By adapting another handling tool, we were able to cut 4m pieces from the roll on the bed, attach them to the lifting rig and place them on the bank with an excavator.

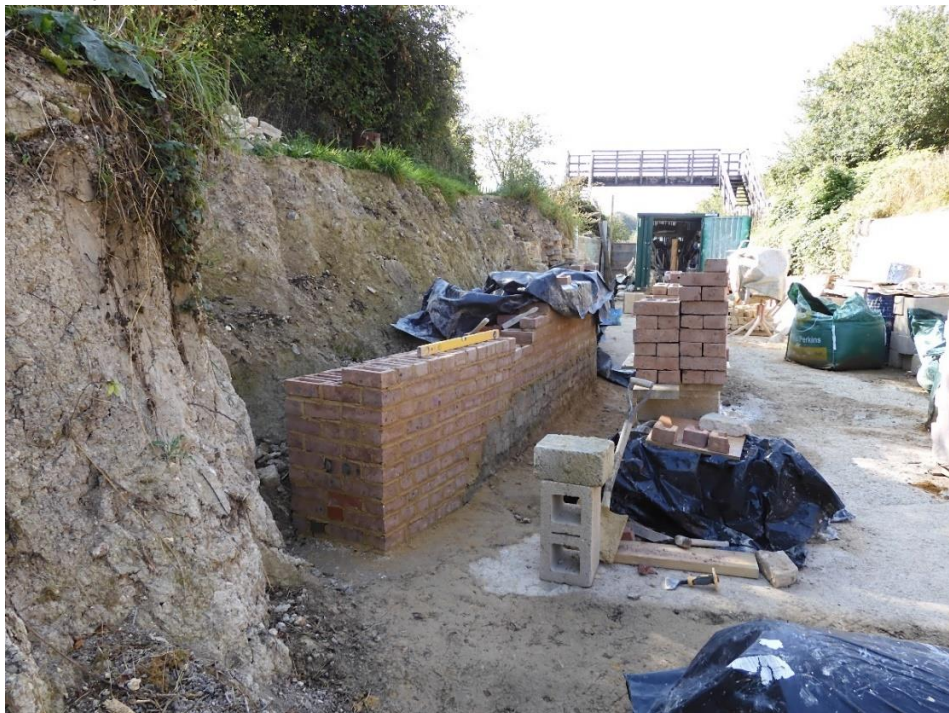
The swing bridge brick work at Bridge 4 has been cleaned up to remove the old crumbling Lime, loose bricks, and other debris. The new “old style” heritage bricks are now being carefully built up with fresh lime mortar.

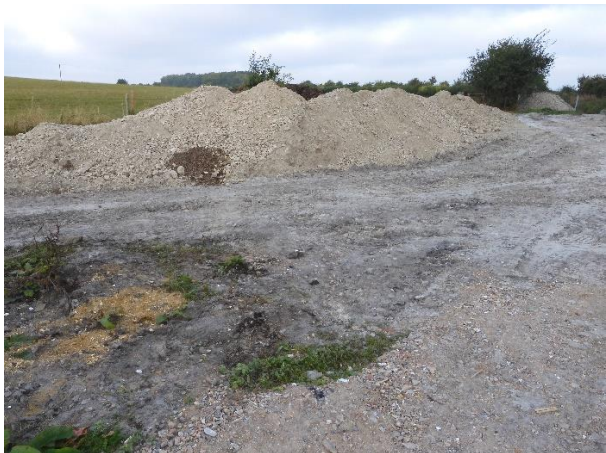
Clean spoil piled up ready for collection Not that exciting to look at, but very important in disposing of the excess material at the right cost.

We have now been a lot more careful when excavating the banks. It has been possible to remove the contaminated top layers and the coal tar layer itself and leave the original clean subsoil exposed and then remove it and keep it separated from the tar contaminated spoil. This in turn has allowed the removal of the "clean spoil": - (we will have a net excess of spoil, so something must be removed from site). This can be done relatively cheaply.

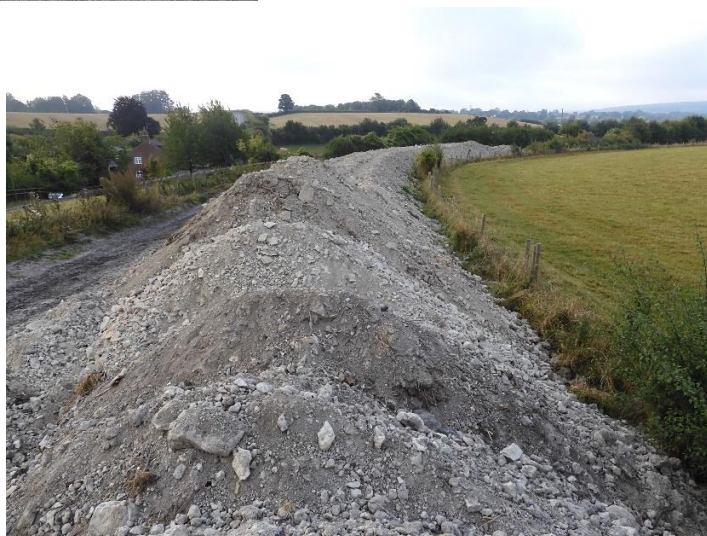
And here is the pile of spoil with lumps of coal tar visible in it. About 100m long and 2.5m high. Currently it would cost 12 times as much per tonne as the clean spoil to get it off site. We will be able to use some of this for backfilling the banks and bed

In 2021 the coal tar is now a problem material when considering how to dispose of tonnes of spoil that now contains the tar. We have found that coal tar is not accepted at all at landfill sites, and that includes spoil with small amounts of the tar in it. We know the tar does not leach into the sub soil and we also know that it is not dissolved in water, or it wouldn't still be there after 100 years or so.

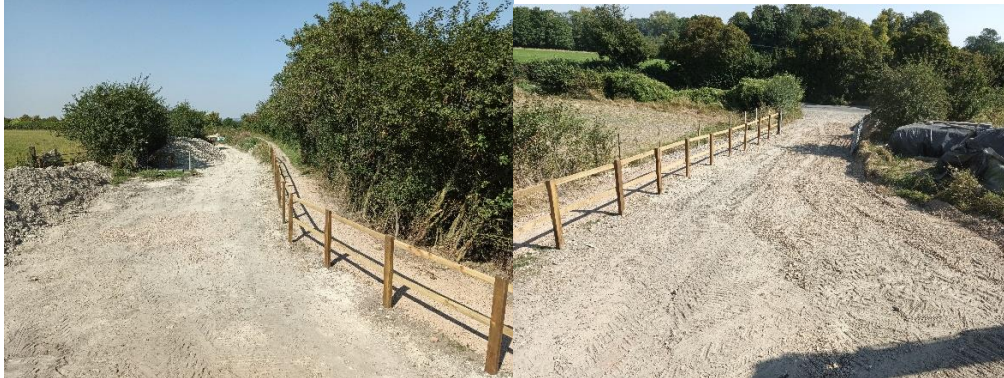
The footpath which goes through the site entrance and along the towpath was segregated from the working area by this new fence. It does stop people wandering over to see what is going on and reduces the risk of mixing people with big machines.

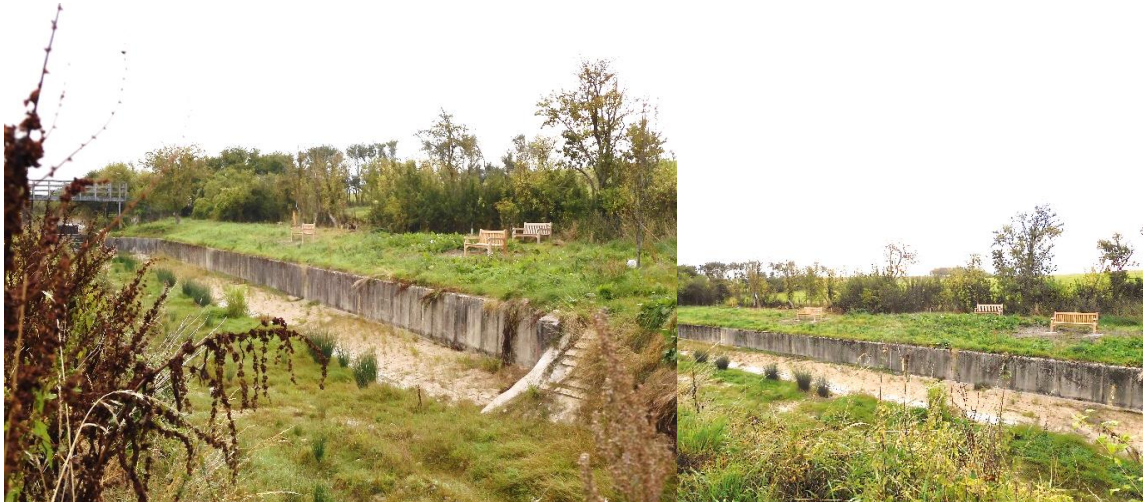
We had a team of volunteers from Network Rail working with us for one day. They carried out the installation of two more benches and we are very grateful to the Team for their efforts. We now have two benches that are now offered to the public to be memorials of their loved ones.

As can be seen here the two benches are on the offside bank just above the Mooring wall next to bridge 4. (The third bench is further back from the wall than it looks and was previously installed)
