Operations Report November 2021

Bridge 4 Old Swing Bridge Brick work

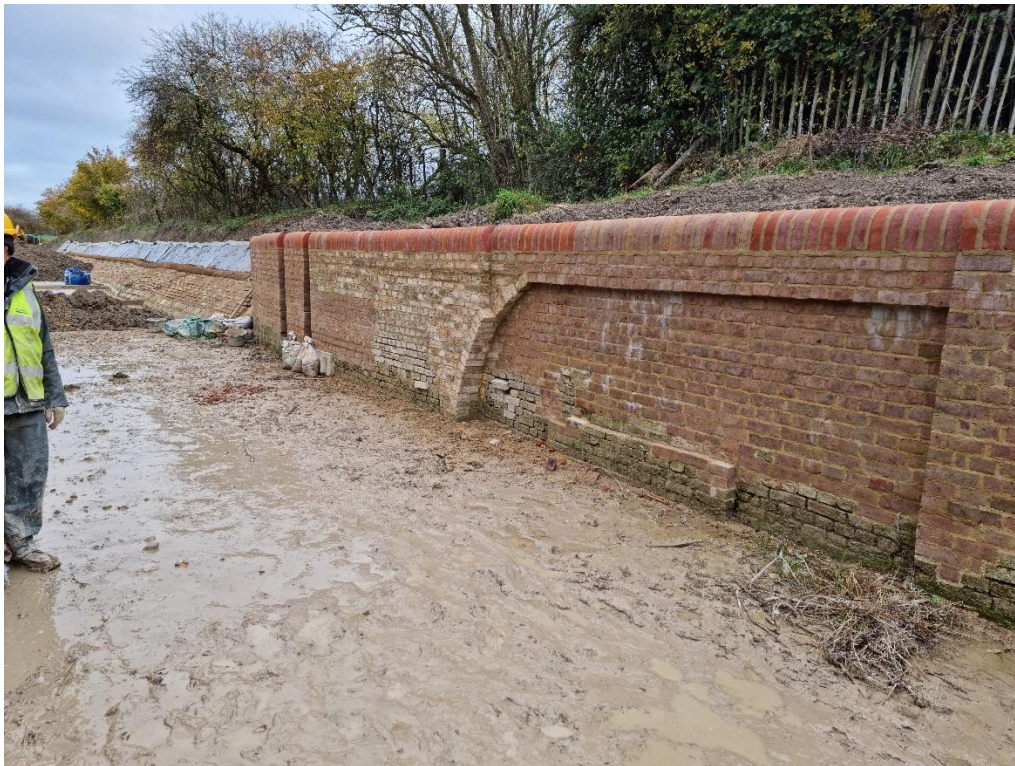
Here we can see the brickwork of Heritage Bricks and Lime mortar virtually complete except for some re-pointing work on the old brickworks lower down. We still don't know what most of the features were for!

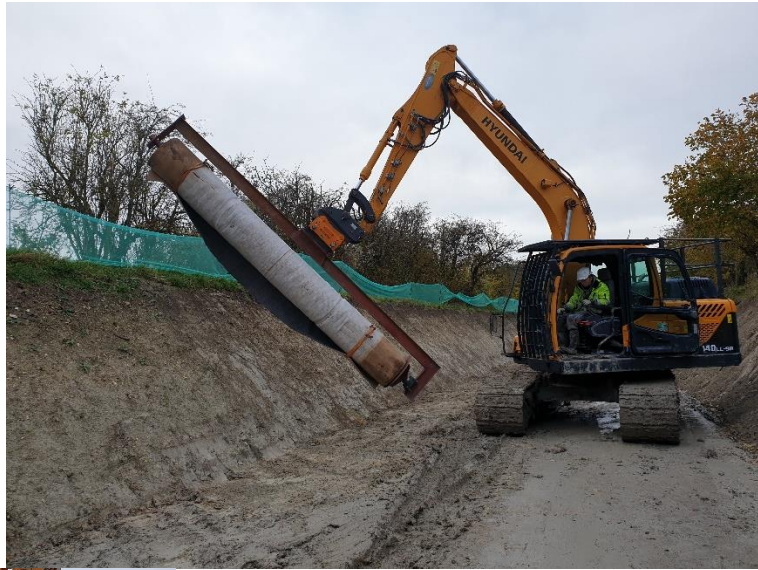
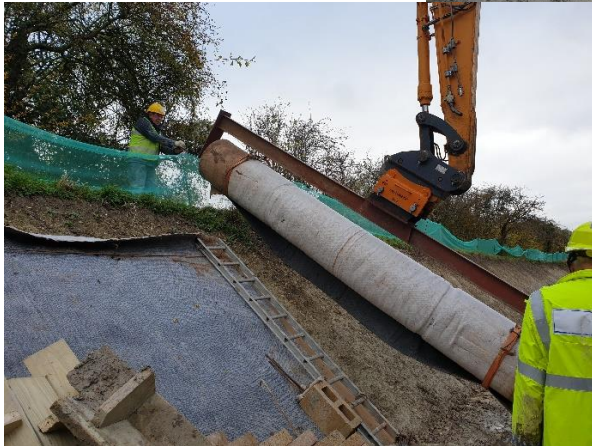
Here we can see the Bentomatic being put into position at the end of the last piece of matting

The end of the mat was pinned in position over the existing one and then the mat was rolled out, stopping every metre to put a pin at the top to stop the mat from falling down. We have made a time lapse video of the whole process which can be seen here: - <https://youtu.be/7UjCXQfmxuY>

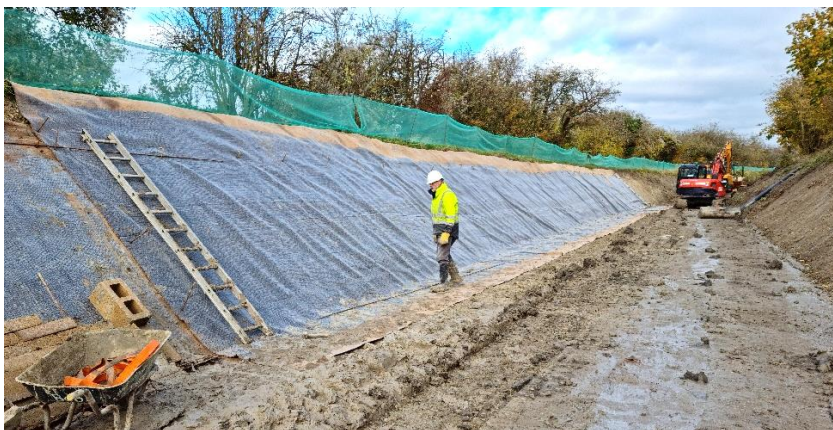
When you access this video, you will be able to see how the unrolling progressed and how many times we went up and down the ladders! The whole process took around 50 minutes and the end result looked like this:

All we have to do now is concrete in the Hollow blocks and put hundreds of solid concrete blocks on top of those!

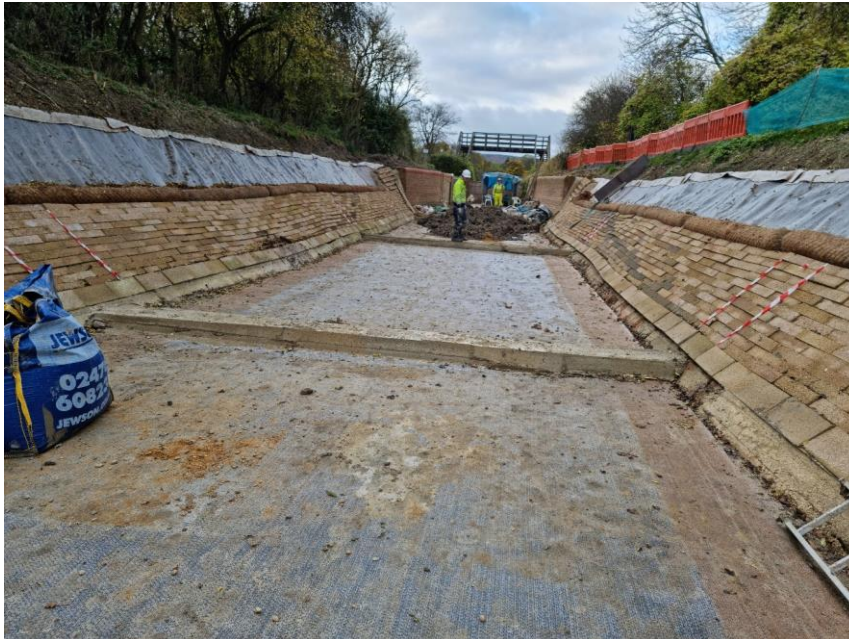
The picture below shows the bed mat rolled out, the bank mat and hollow blocks/solid blocks in position ready for the construction of the “concrete sleeping policemen”. We have one of these reinforced concrete structures on every bed mat join to stop the mat end being disturbed in the future. We also have them every 10 metres to aid the bank stability.

After the “policemen” have cured, spoil is tipped on to the mat at the end nearest the camera and then the spoil is run over by the excavators and dumper to protect the Bentomat and policemen.

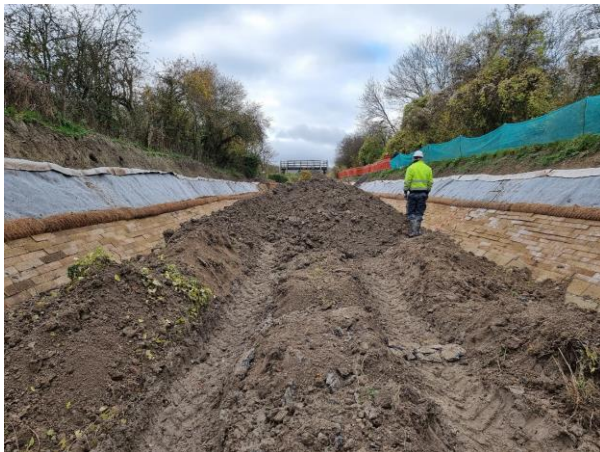
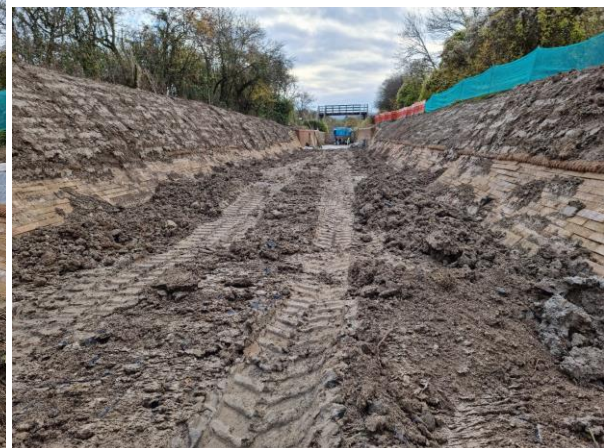
More spoil is brought along and then piled onto the banks as shown in the third picture. After a bit of cleaning up, this section is finished.

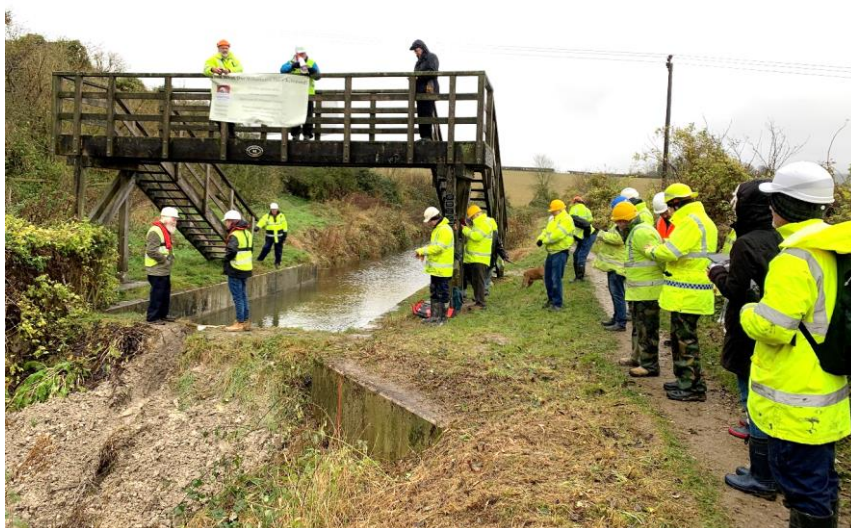
The volunteers standing on the bund with floatation aids are getting ready to lift out the board which is stopping the flow of water from the re watered section beyond bridge 4a. The water in that section is connected to the supply from Wendover so as the level drops it will be replenished.

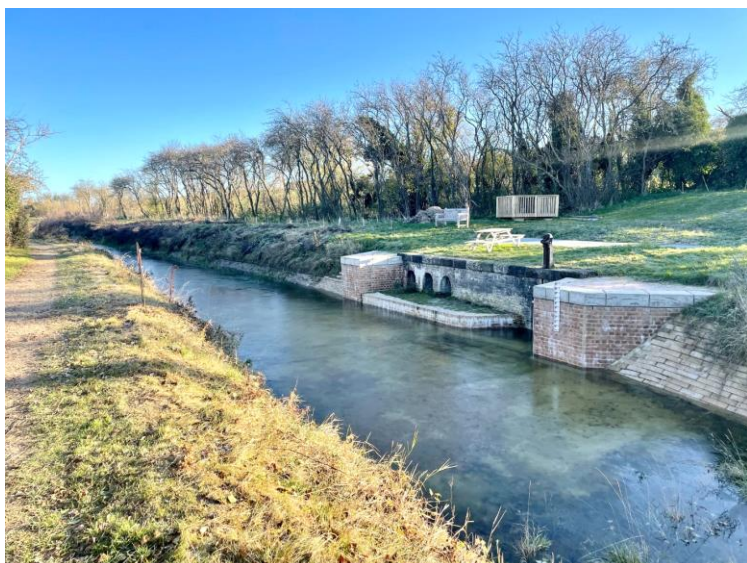
Next day this was the water level at Whitehouses. The water surface looks hazy because it was frozen over!

The apron jutting out under the three arches is where the first water level is to be set for the first tests.

The rewatering process will be carried out in two stages. The first is to fill up the section to the top of the apron at Whitehouses. At this point the board will be put back into the bund to stop incoming water flow and we will then monitor the water level for approximately two weeks to make sure we have no leaks. This will include any leaks at the stop planks. When the Engineer from Canal and River Trust is satisfied, we will pull the board out of the bund again to let the water level rise to be the same as the water flow from Wendover. We can carry out another “still” test at that point to check for leaks and problems.
