Wendover Canal Trust – December 2022 Work Party Report

The one-week December work party started on 2nd December.

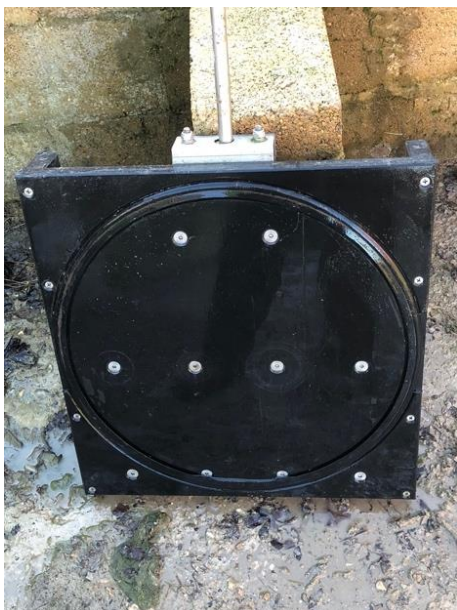
A new gasket was cut and fitted to the backing plate to the sluice gate. The gate was refitted and the operation checked. A water test could not be carried out because of the lack of water in the canal.

New gasket cut and fitted.

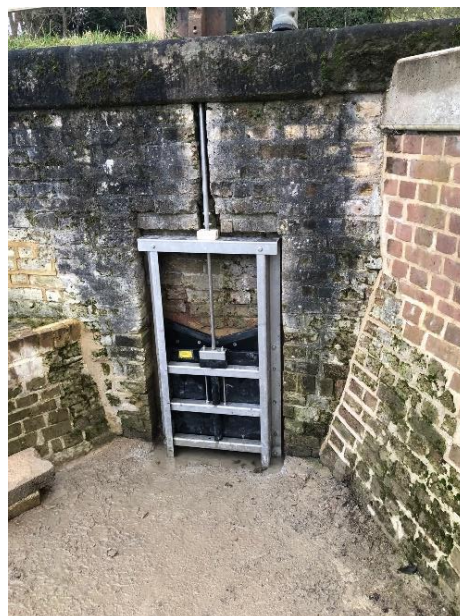
The sluice gate refitted.

A separate report detailing the work carried out to the sluice gate will be prepared for Canal and River Trust records.

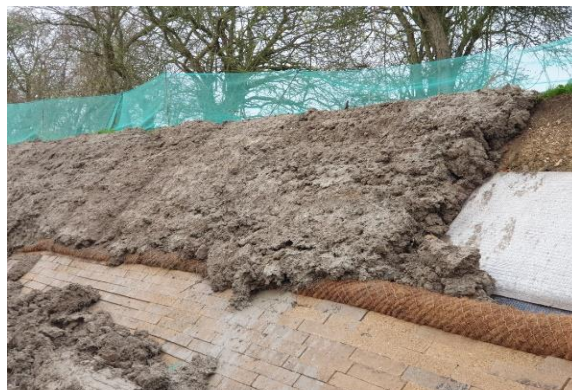
Some spoil was placed on the banks where the bed mat had not been rolled out.

Spoil placed on the towpath bank.

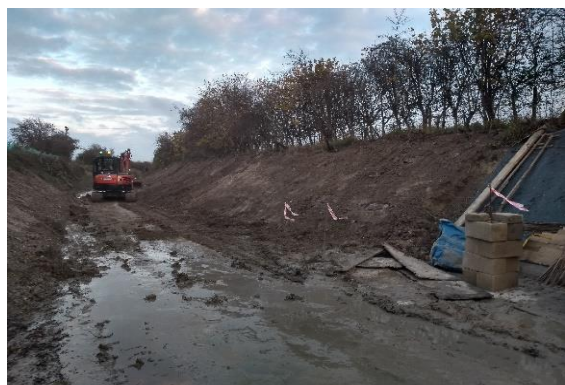
Rough profiling of both banks was carried out along the canal channel from the last lined section towards our car park.

Rough profiling off side bank.

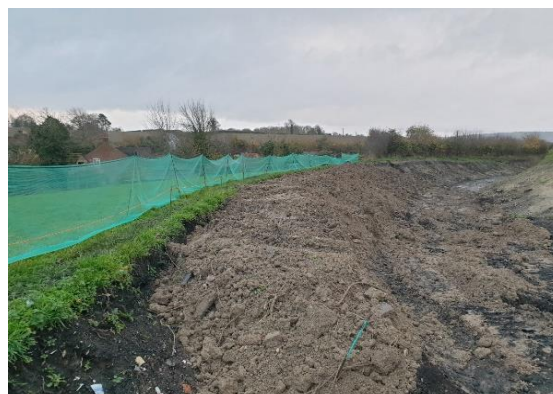
The spoil was used to backfill sections of the former tip where the ash has been removed and the towpath bank needed widening.

Spoil placed to widen towpath bank.

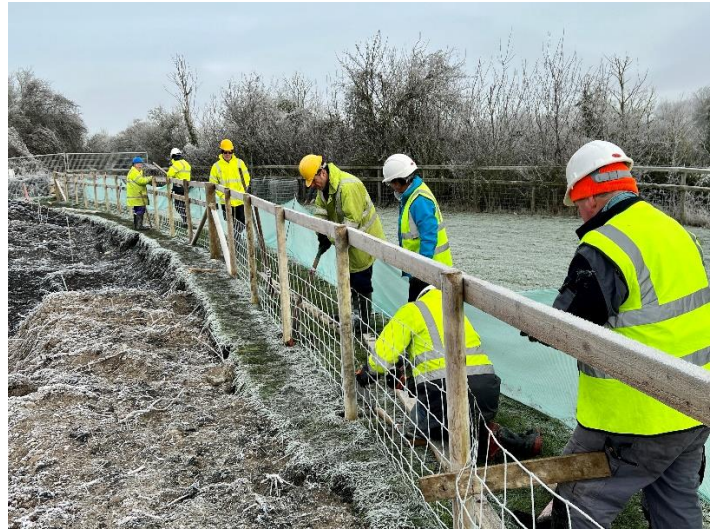
The main activity during the BITM weekend was to install the fence between Little Tring Farm and the canal.

BITM installing the fence on a cold and frosty morning.
