Wendover Canal Trust – February 2023 Work Party Report

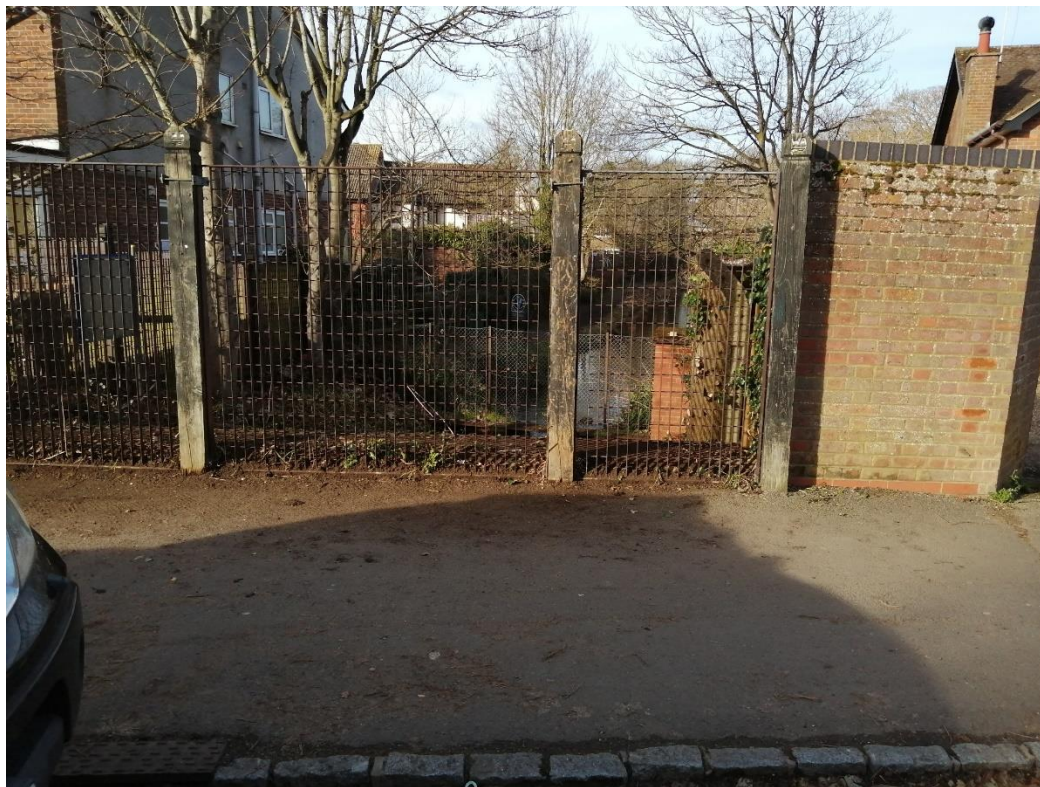
Clearance at the Wharf Road entrance to the Wendover Canal.

In addition, the vegetation was cleared at the Wharf Road entrance to the canal as shown above, allowing the canal to be seen from the road.

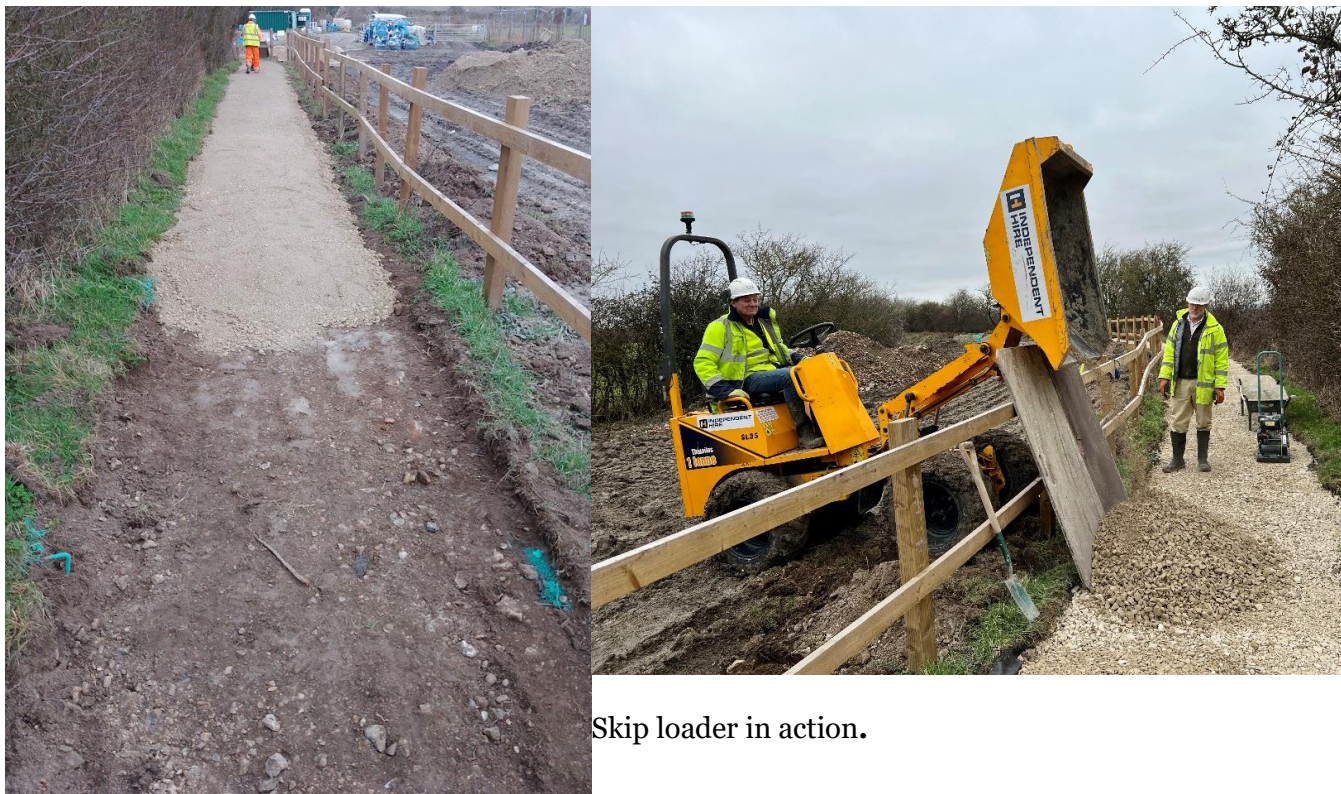
Skip loader in action.

To reduce the manual labour WCT purchased an electric powered wheel barrow which proved to be very useful. A later section of the towpath employed a 1 ton 'skip loader'. This is a small dumper with scissor lift that can raise the hopper. It was used to tip the Type 1 from outside the fence.

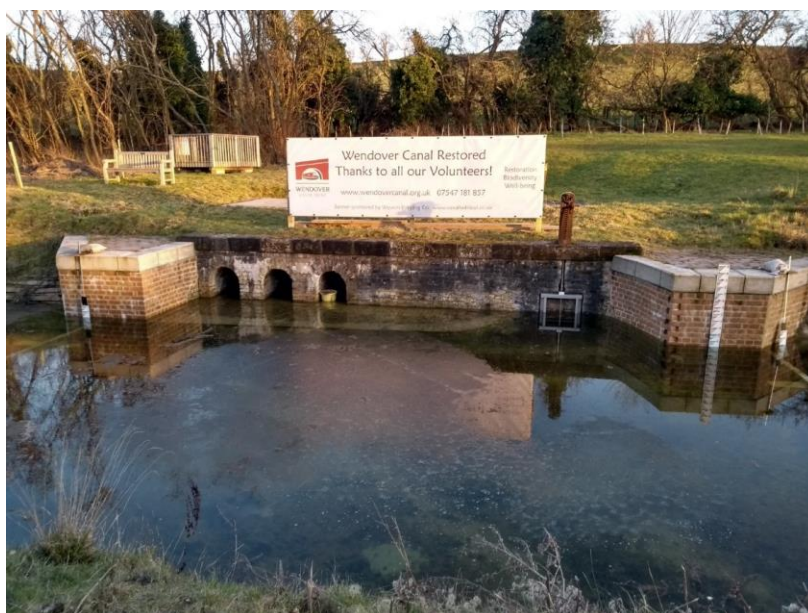
A good water level at Whitehouses

WCT were able to check the repair to the sluice at Whitehouses. The sluice was found to be watertight so the repair that WCT had carried out proved to be successful.

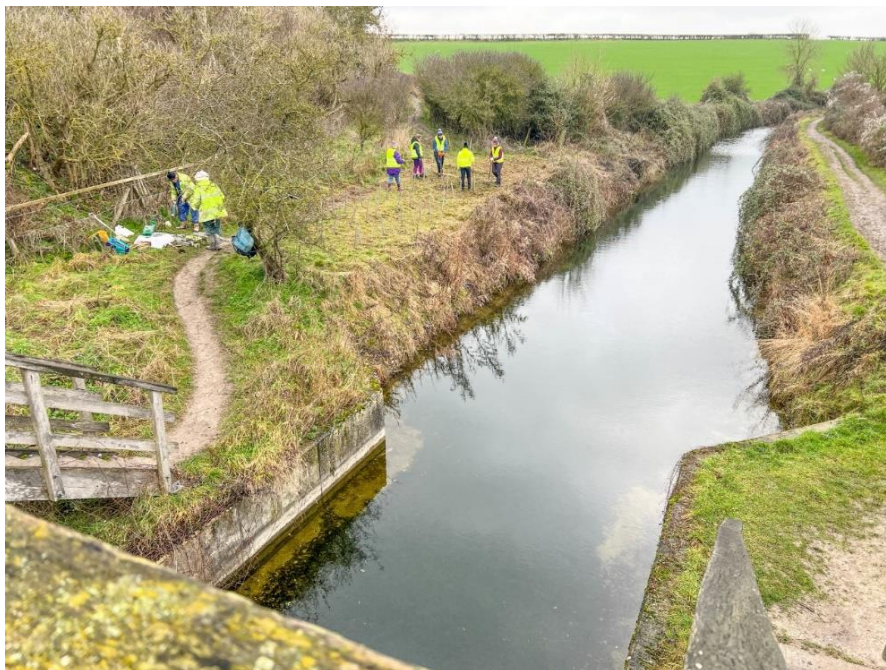
Volunteers from Waterman Aspen working at Bridge 4a.

They cleared an area at Bridge 4a and planted 90 saplings which will form the woodland created in honour of Queen Elizabeth II.
