## **Wendover Canal Trust – March 2023 Work Party Report**

The plan was to continue the canal lining and the seal the stop planks at Bridge 4 from leaking water.

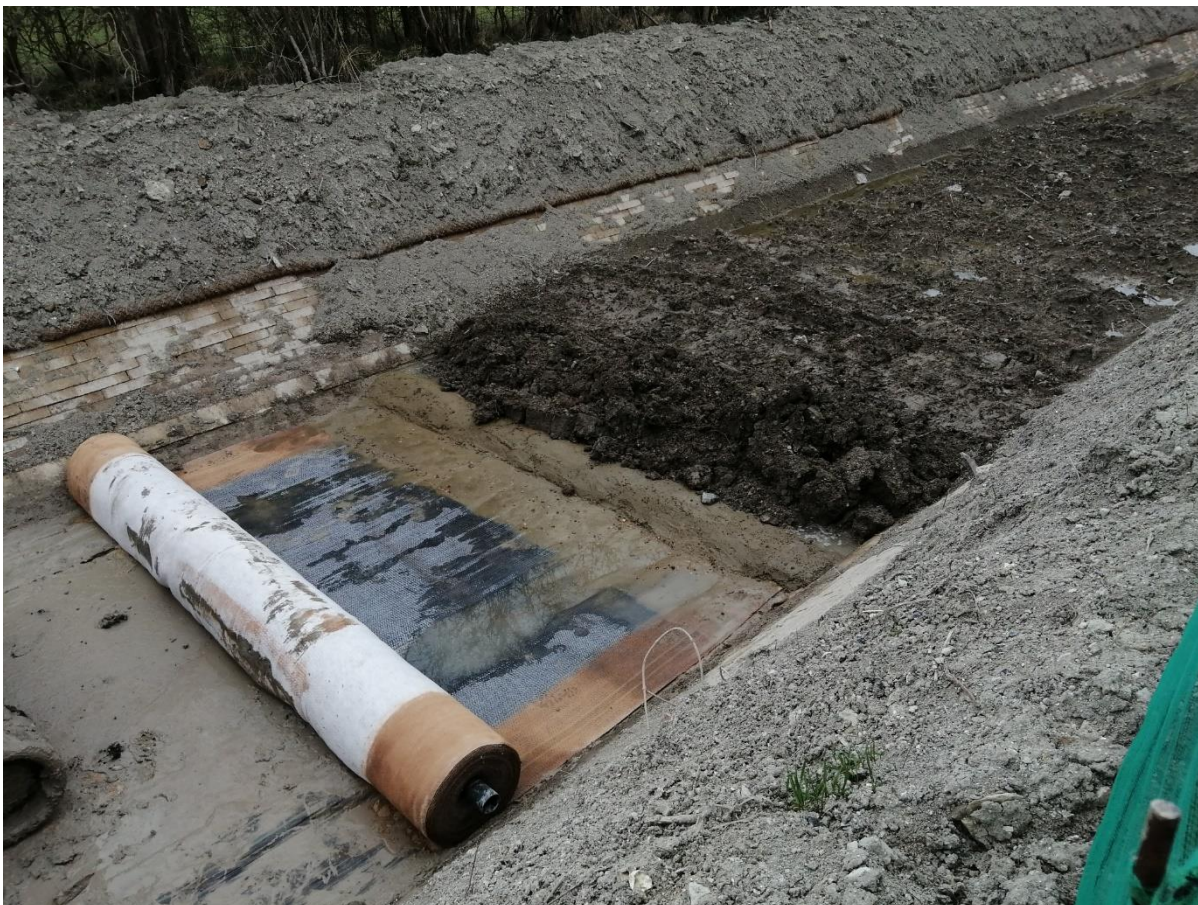
The new roll of Bentomat was joined and rolled out over approximately 20m. Sleeping policemen (Concrete struts placed across the bed of the canal to protect the join and to provide support at the base of the walls) were cast and the Bentomat backfilled.

**Bentomat joined and sleeping policeman cast.**

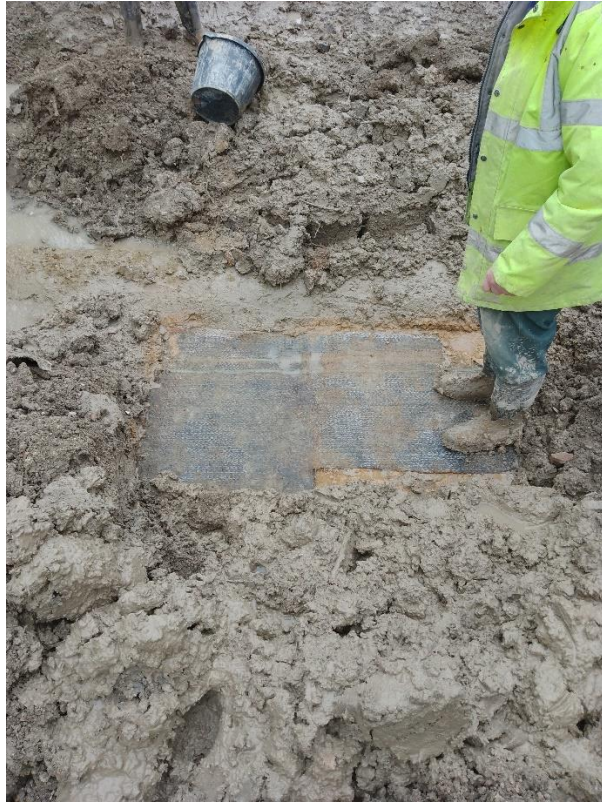
A patch repair was made to the Bentomat where the new roll was seen to be damaged when it was being installed.

**Patch repair to Bentomat.**

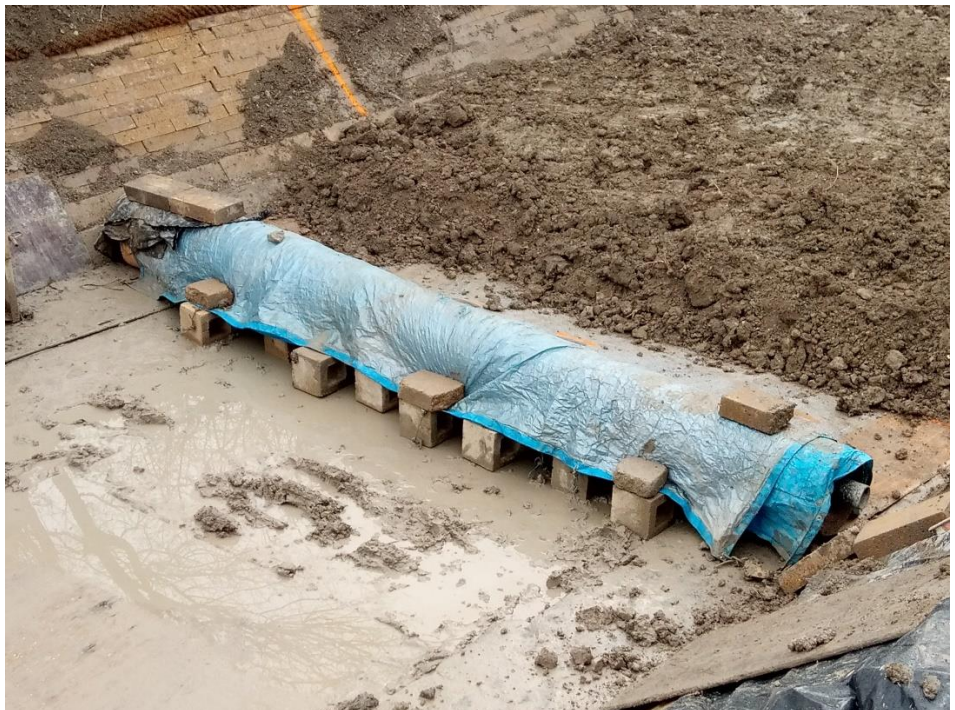
The surplus roll of Bentomat was raised off the canal bed and secured on hollow concrete blocks and covered with sheeting to protect it from the weather.

**Surplus Bentomat stored on blocks.**

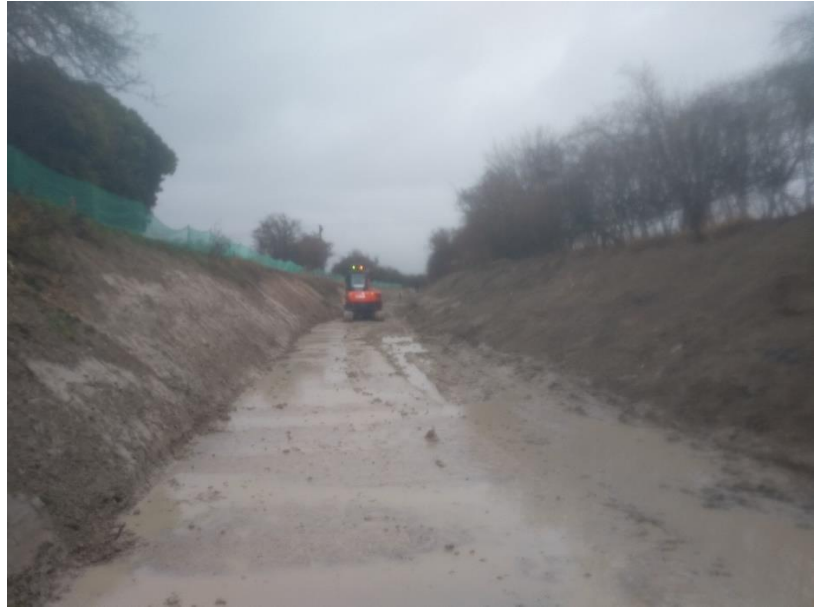
Final profiling to receive Bentomat was carried out on the towpath side for approximately 40m.

**Final profile to the towpath (left) side.**

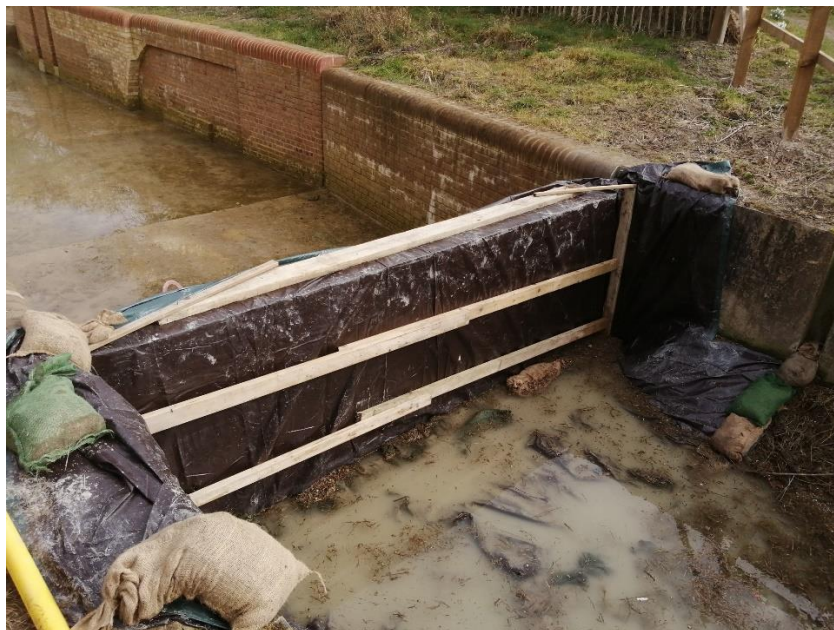
The lifting handles were removed from the back of the stop planks and a tarpaulin was installed. The tarpaulin was secured in the bed of the canal with sandbags and up the sides using Bentomat and timber battens. The top was secured with a timber batten.

**Tarpaulin secured in place.**

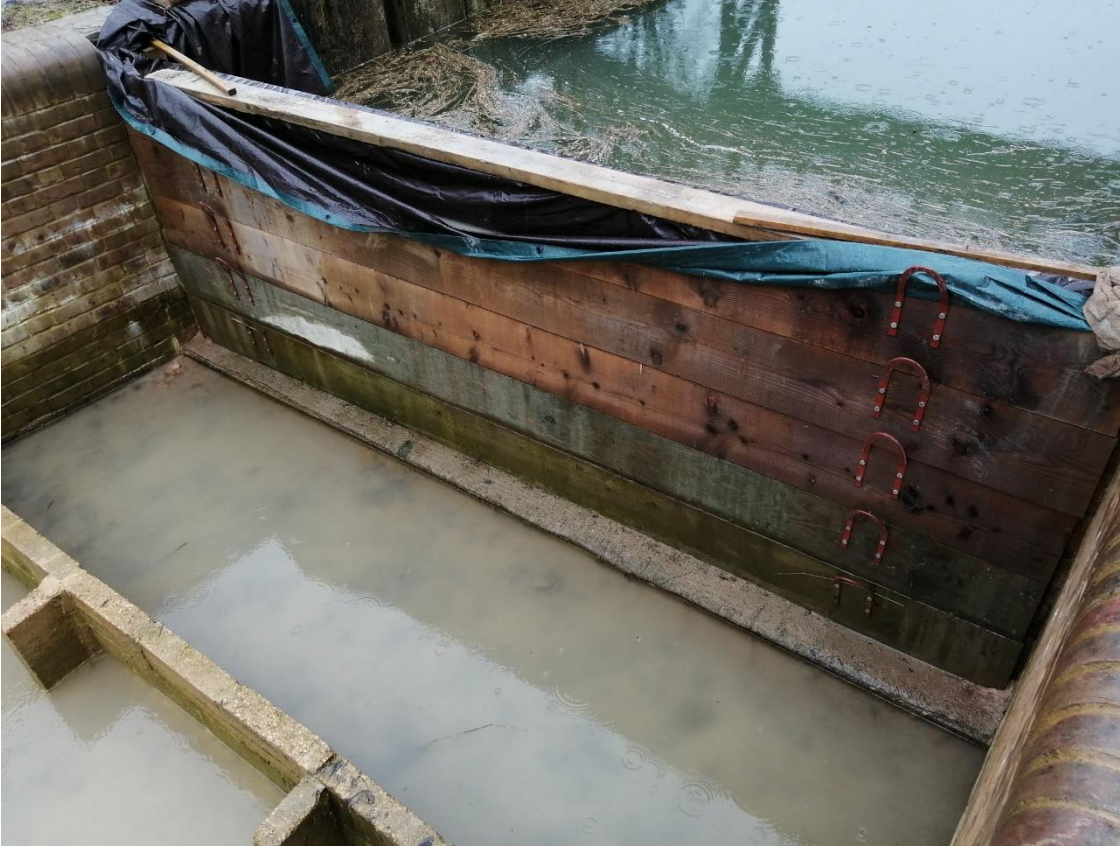
Very little seepage through the stop planks was observed and at the end of the work party the canal level had risen to approx 600mm below the top of the concrete walls at Bridge 4.

### Successful sealing of the stop planks.

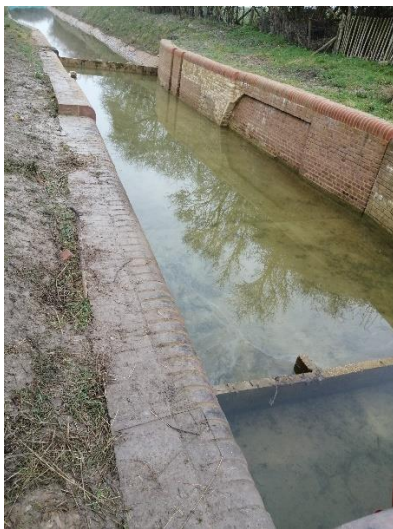
Before

During the work party a lot of the water that had accumulated in the canal bed was pumped out in order to allow the backfill material to dry out so that later in the year the final section of bank backfill can be completed.
