Wendover Canal Trust – March 2024 Work Party Report

Wharf Road.

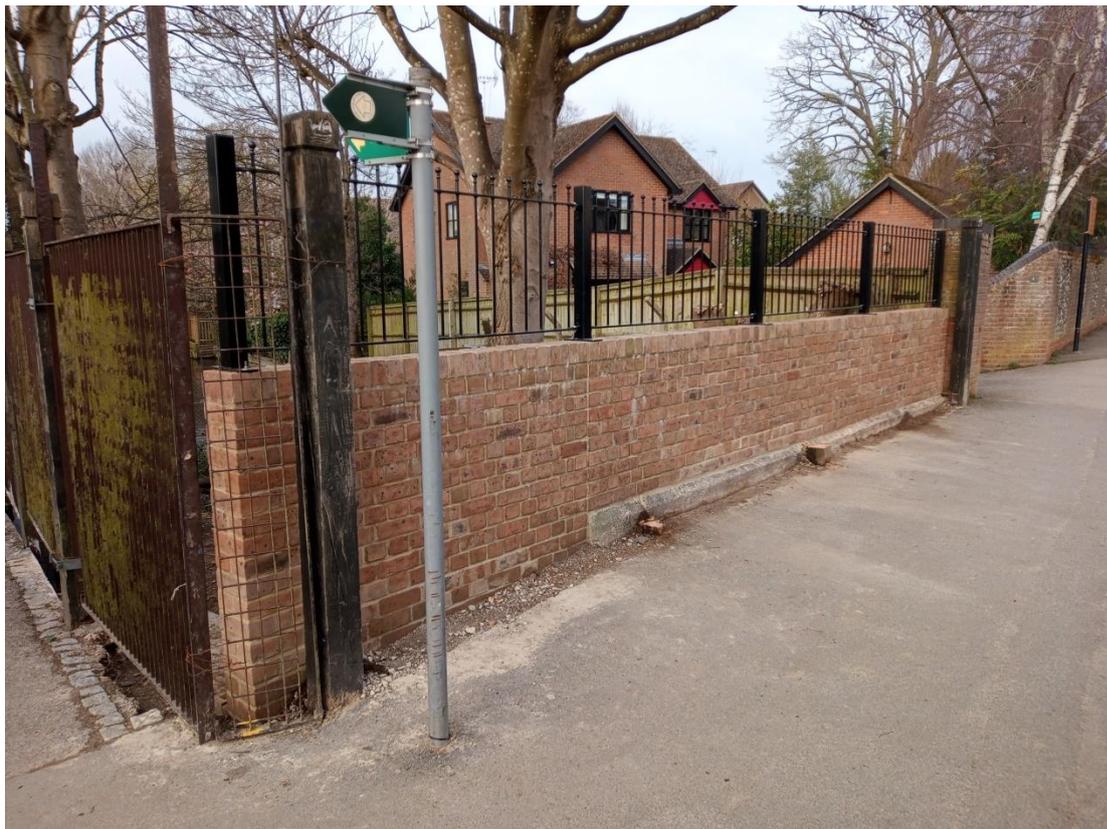
Wall with railings installed.

The railings were installed to the wall along Wharf Road. Initially there was a problem with the chemical anchors, but a two-part resin adhesive was used successfully in place of the chemical.

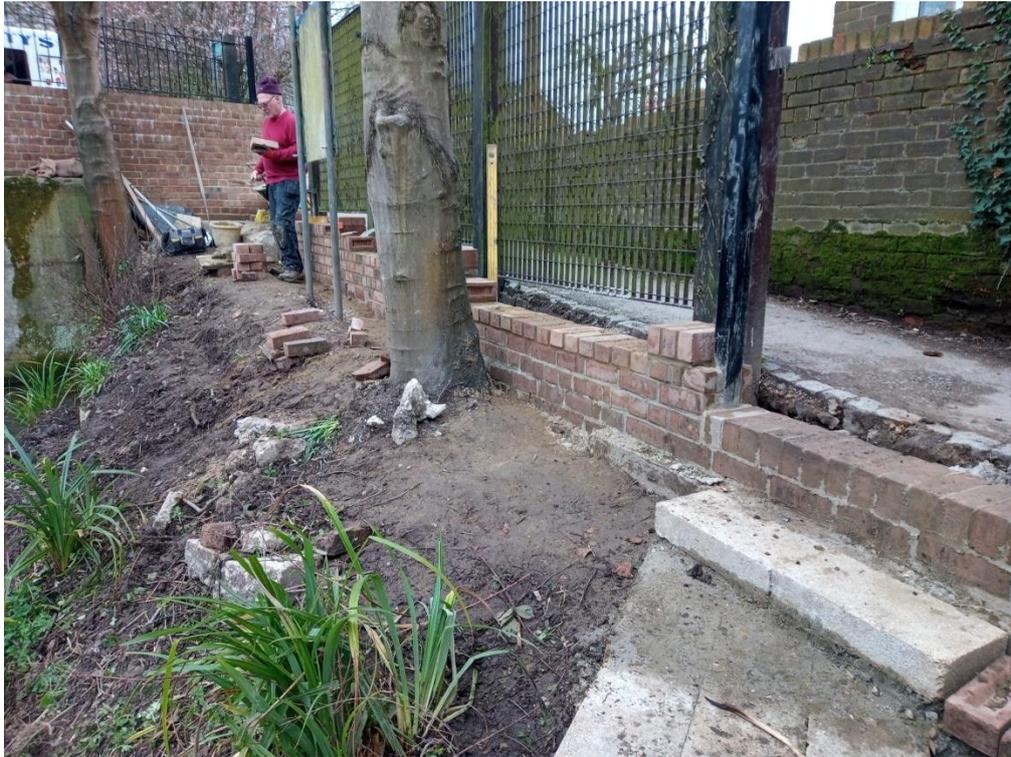
Low wall alongside the towpath.

The low wall alongside the towpath was started and the return at the end completed.

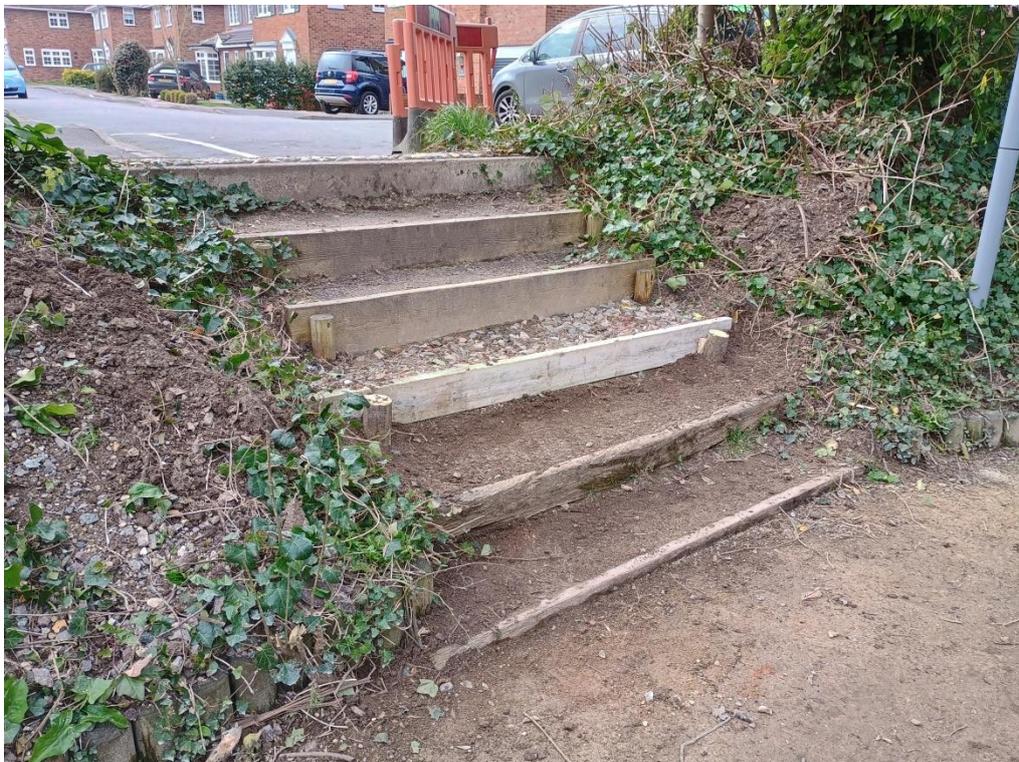
Repaired steps to Bankside.

Steps from the towpath to Bankside were repaired by replacing the timber riser and building up the backfill forming the tread.

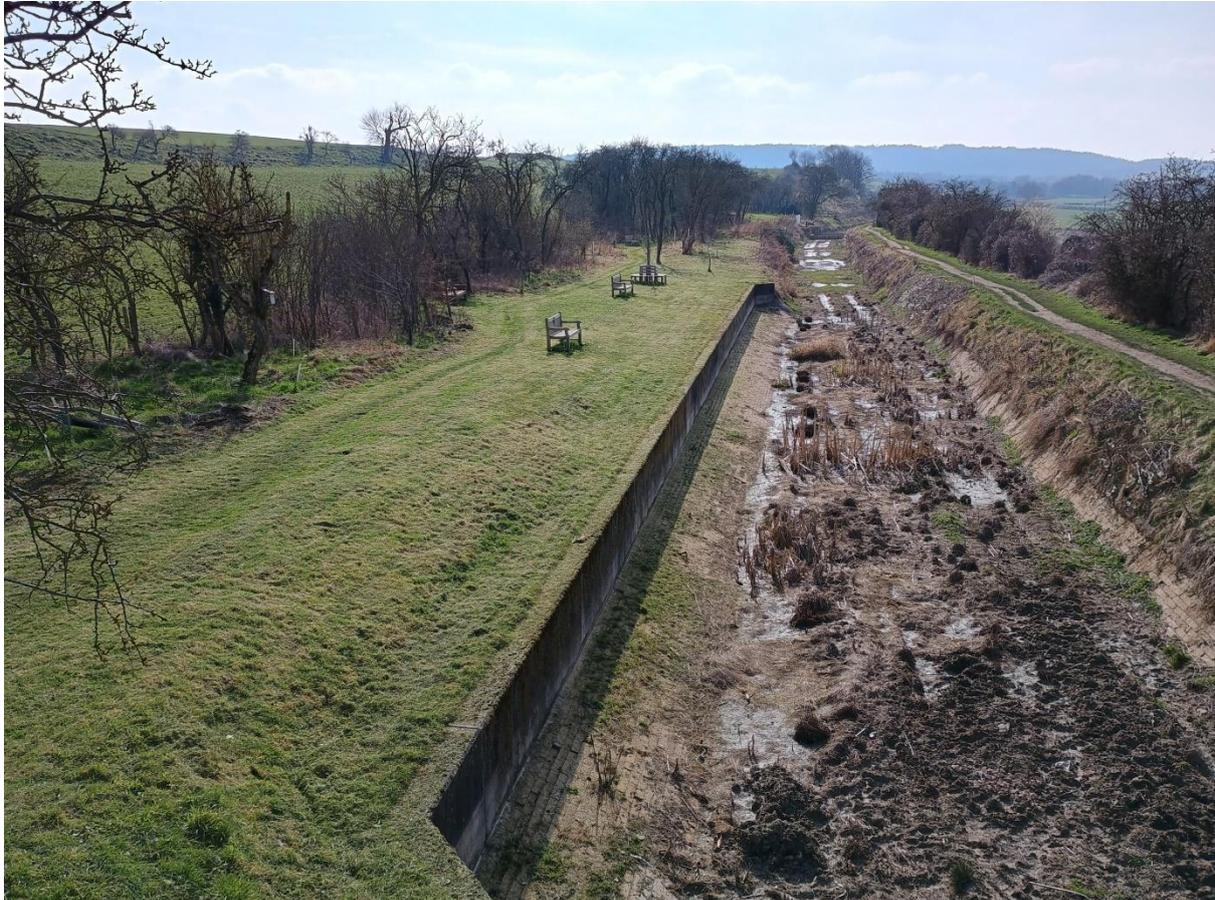
Pocket Park after grass cutting.

The grass was cut in the pocket park between Bridge 4 and the copse of trees. The arisings were raked up and disposed on site in the boundary hedge.

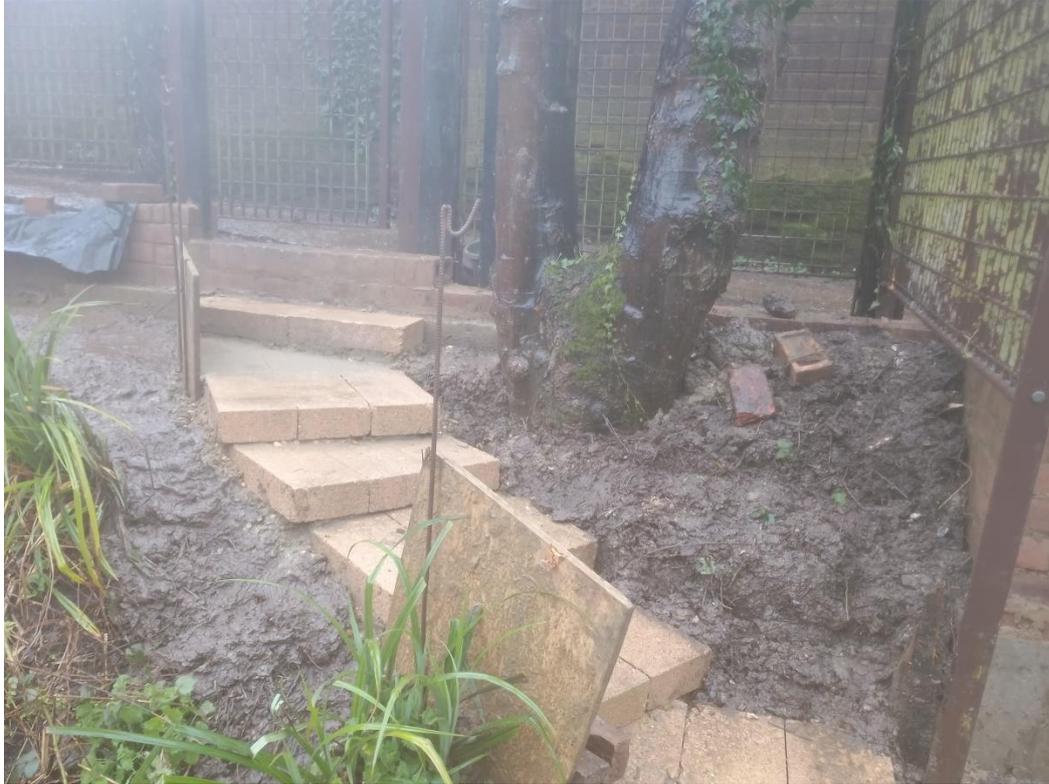
**Steps from towpath to weir crossing.****Extra day 14th March.**

Steps were installed from the low wall to the platform across the weir. Solid concrete blocks and in situ concrete were used to form the steps. These steps are located inside the compound and allow Canal and River Trust staff a safe means of access to the monitoring station.

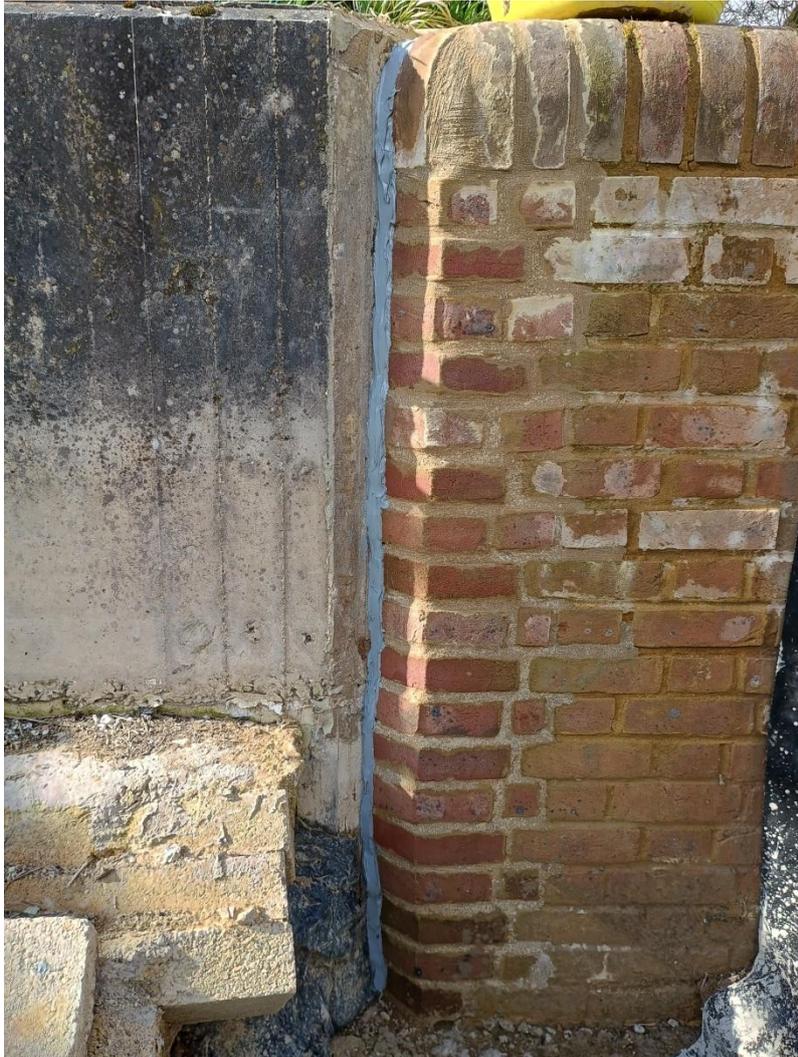
Joint in the wall sealed.

A second group of volunteers worked at Bridge 4 to clean out the joints and install the Polysulphide sealant. When applying the sealant, the manufacturer's instructions were followed and volunteers were made aware of the COSHH (Control of Substances Hazardous to Health Regulations) assessments for sealant and primer. All joints were sealed.
