# Wendover Arm Trust

## Operations Report 26 August 2021

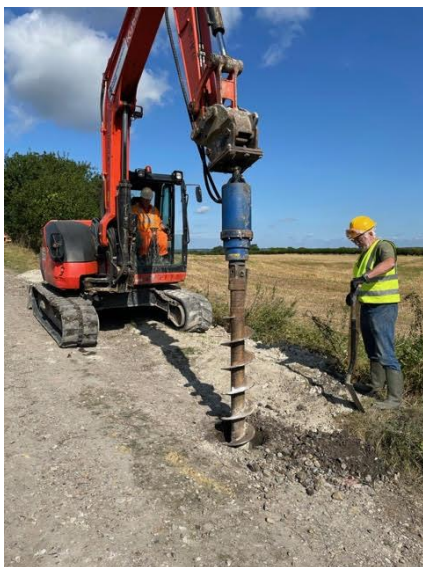
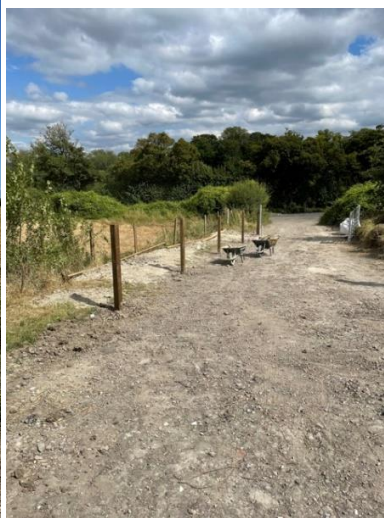
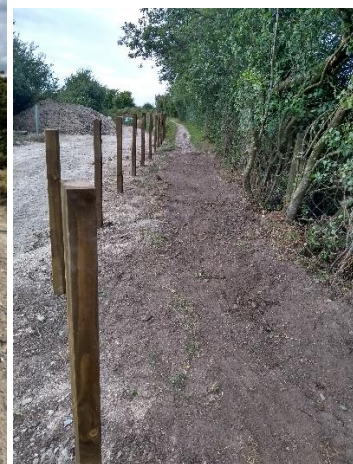
We had a new toy to play with! After our recent break in where the gate was damaged, it was decided to rebuild, with the gates and the foot path from the road to the towpath in a new position. One reason was to assist large vehicles to enter and leave the site, and the other to make sure pedestrians using the towpath are kept separate from the various machines being used on site. The associated fencing was started.

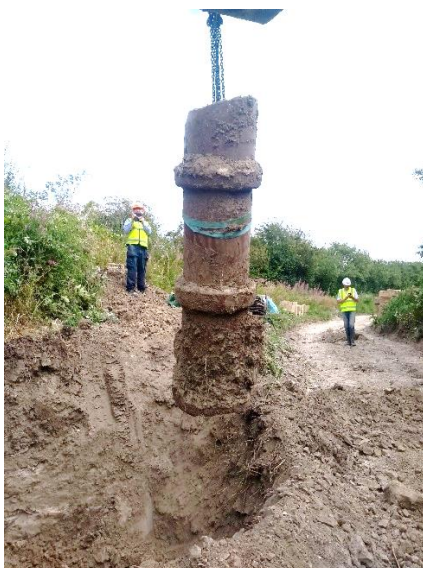
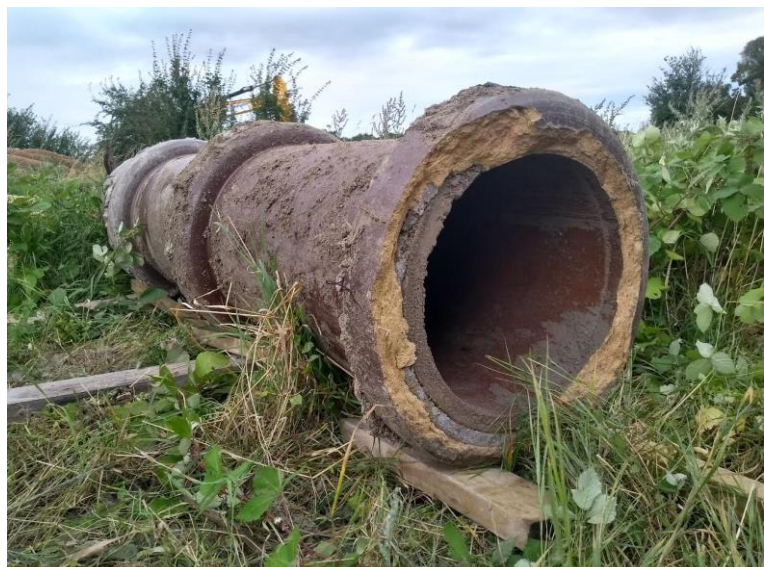
Bed excavation continued for next month's concreting, and that included the lamp hole vertical pipe area as well. A section of pipe was removed intact and will be kept as the only large section of pipeline to have been salvaged. It is currently being carefully stored and will become an exhibit at Whitehouses for everyone to see.
