Operations Report January 2020

Weekend report (from Mike Wright)

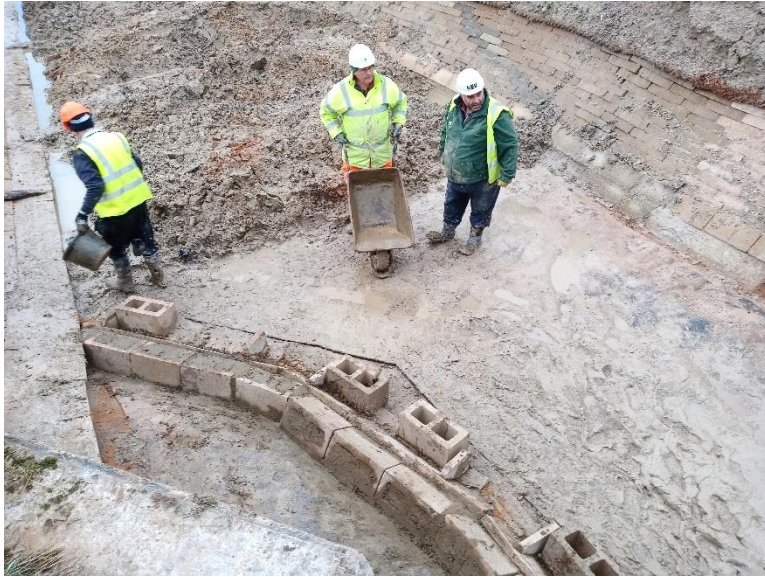
Monday 6th: 5 volunteers. Loaded more hollow blocks, ballast & water & transported to site. Crushed concrete delivery am. Laid towpath side 2.5m strip & installed hollow blocks

The hollow blocks nearest the existing blocks were filled in an “upright” position and subsequent ones were laid at 45 degrees as is normally done on the bank block work.

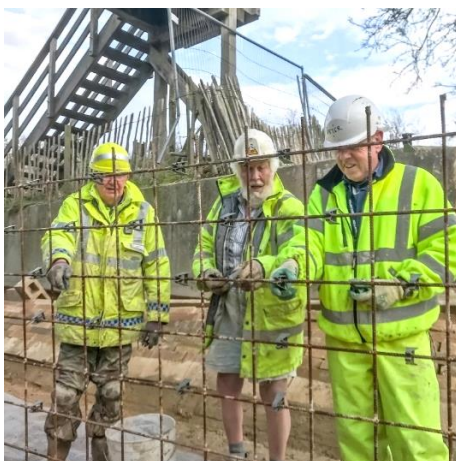
We set out some more formwork for the bed concreting and commenced on preparing the reinforcing mesh by attaching some “standoff” feet.

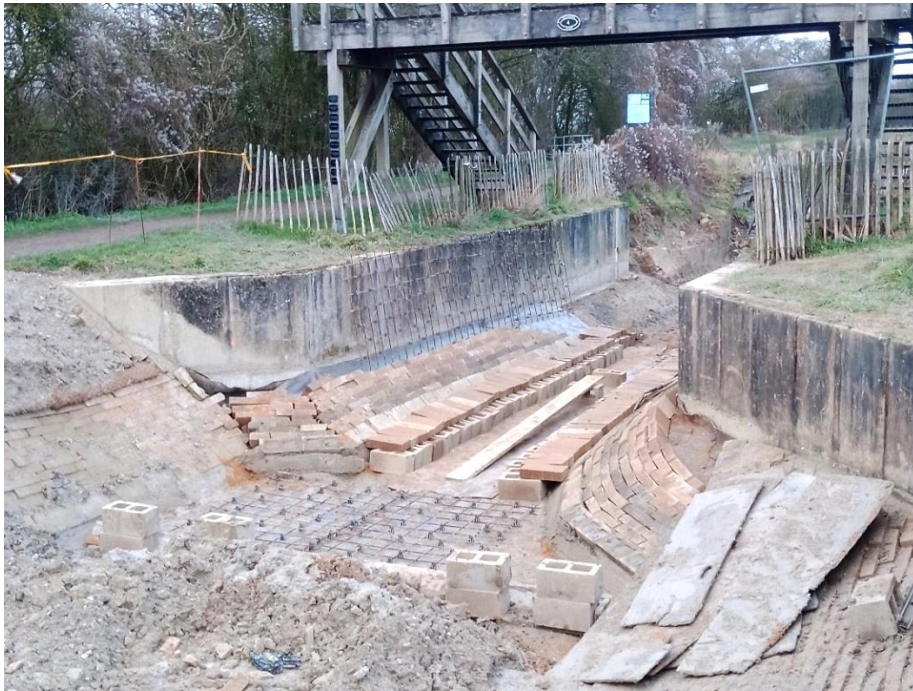
Last thing on Tuesday 7th it all looked like this: -

You can see in this picture that there is a row of hollow concrete blocks topped with solid blocks. This was done to allow the dumpers to bring the concrete to the required place and thus reduce the amount of manual shovelling needed. The arrangement was tried, adjusted and tested again to make sure it was stable, and the blocks could withstand the loads generated by a dumper with a wet concrete load. All set for the concrete to arrive on Wednesday.

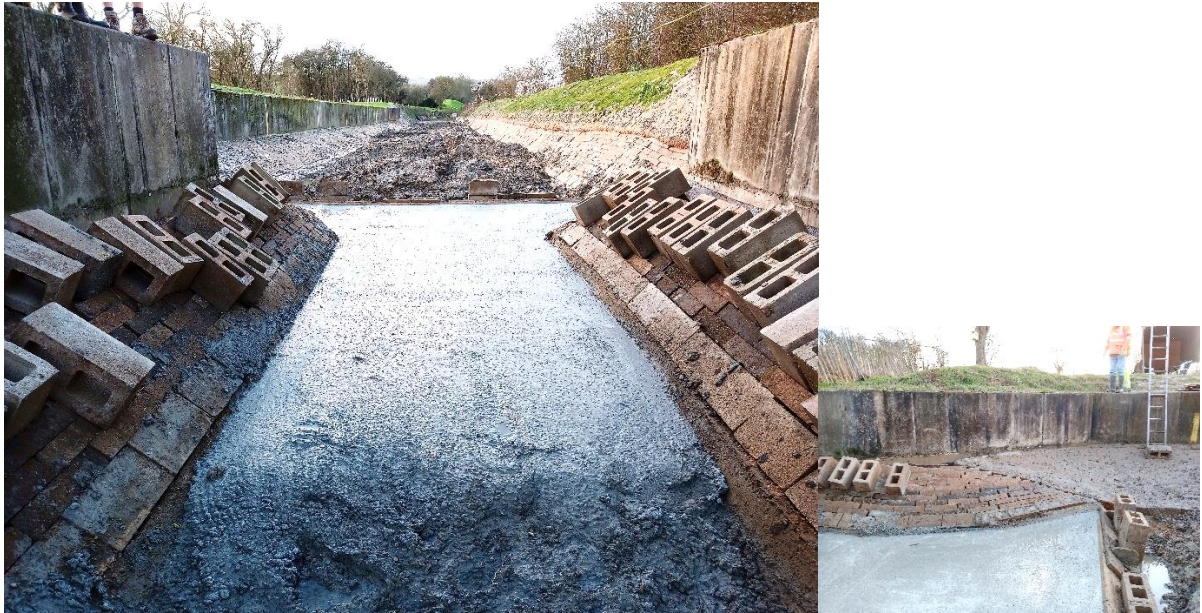
Next day (Thursday 9th) this is what it looked like: -

It was now time to use concrete to infill the gap between the blocks and the bridge walls and carefully fill the gaps in the block work. At the same time fresh Bentomat was laid on the next part of the bridge banks and the form work laid out ready for a quick start next month.

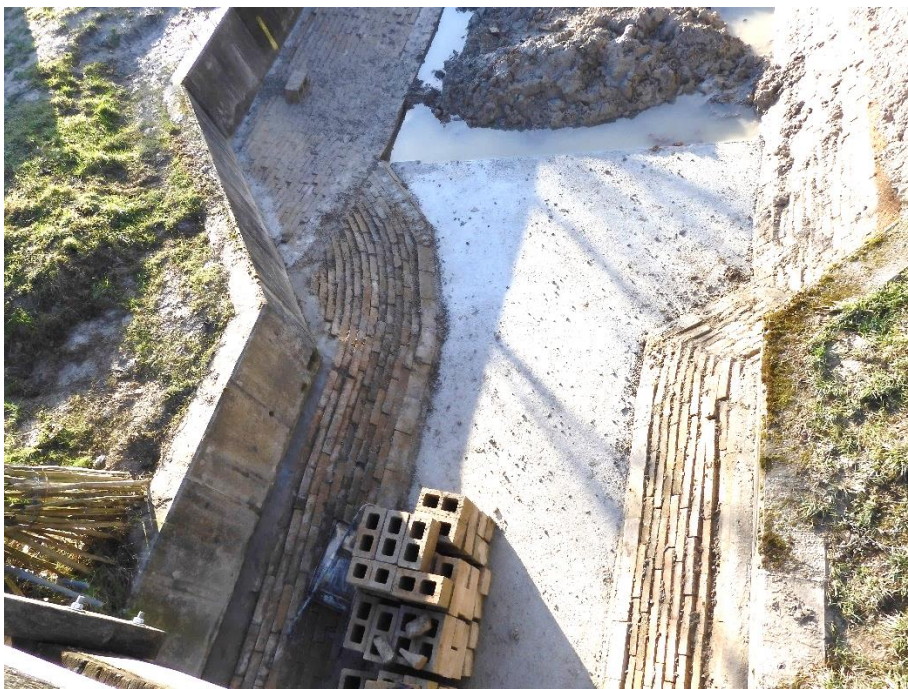
The view looking directly down from bridge 4

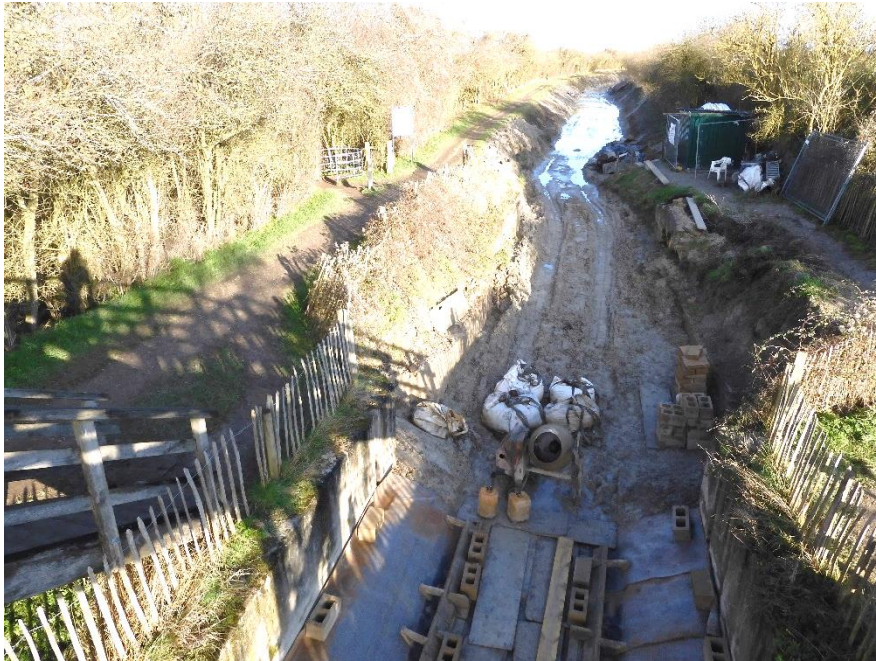
View from Bridge 4 going the other way showing the materials etc. ready for February, plus a large lake to quell!
