July 2019 on the site

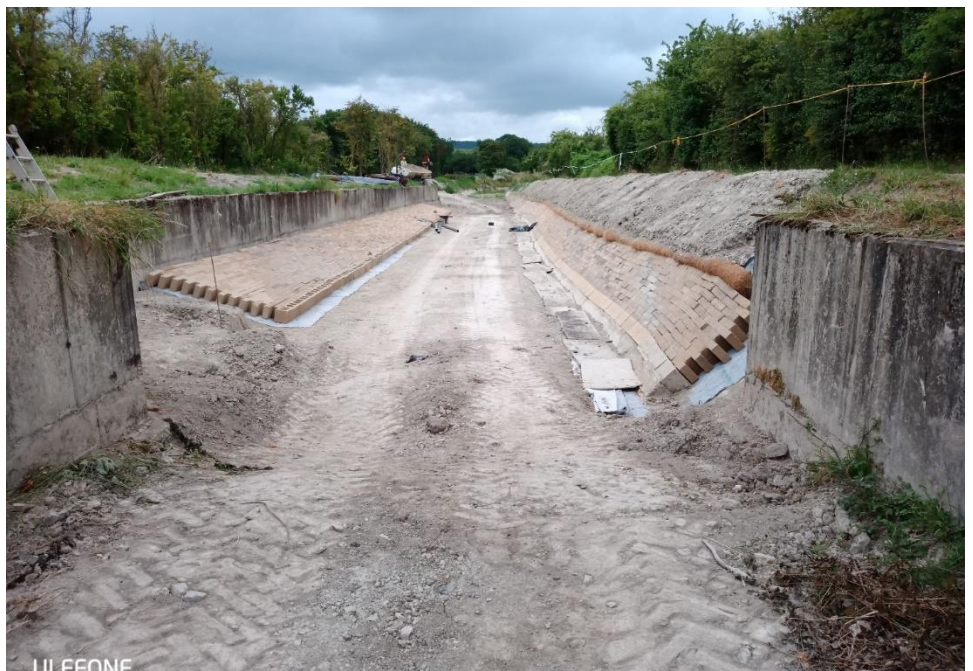
View under bridge 4

On the towpath side the Bentomat liner was extended to the Bridge 4 wall and the solid and hollow concrete blocks were concreted in place. All the exposed mat on the towpath bank was back filled with spoil, except for the last metre or so to allow it to be connected to the wall later.

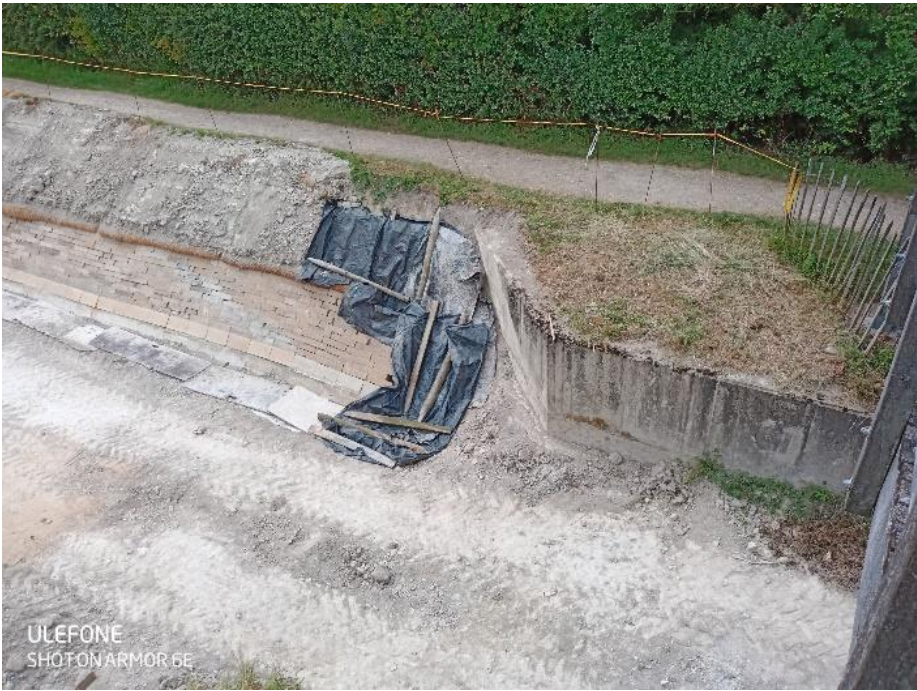
Left - View from top of bridge 4

Bentomat blocking and back filling up to Bridge 4 abutments.
