Wendover Canal Trust – April 2023 Work Party Report

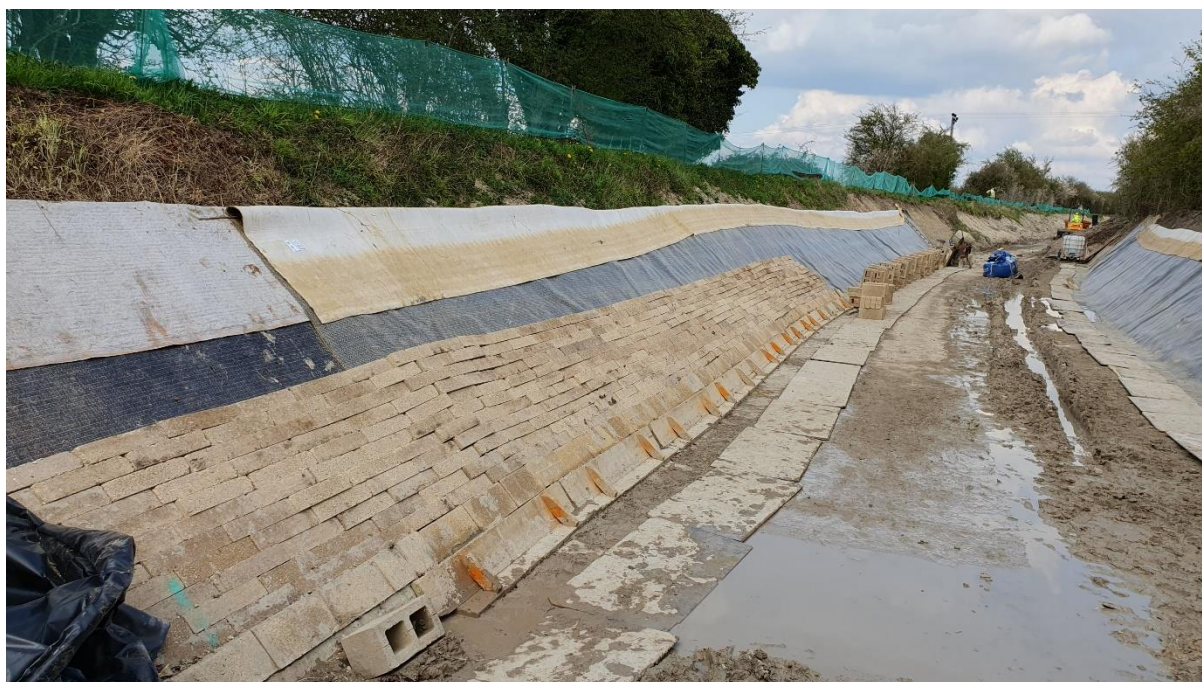
Towpath side with the blocks placed.

40m of Bentomat was rolled out on each bank over the middle weekend. The remainder of the work party was spent placing the hollow blocks, concreting the foundation on both sides. On the towpath side solid block and the coir roll was completed. On the offside the hollow blocks were placed, and the foundation concreted.

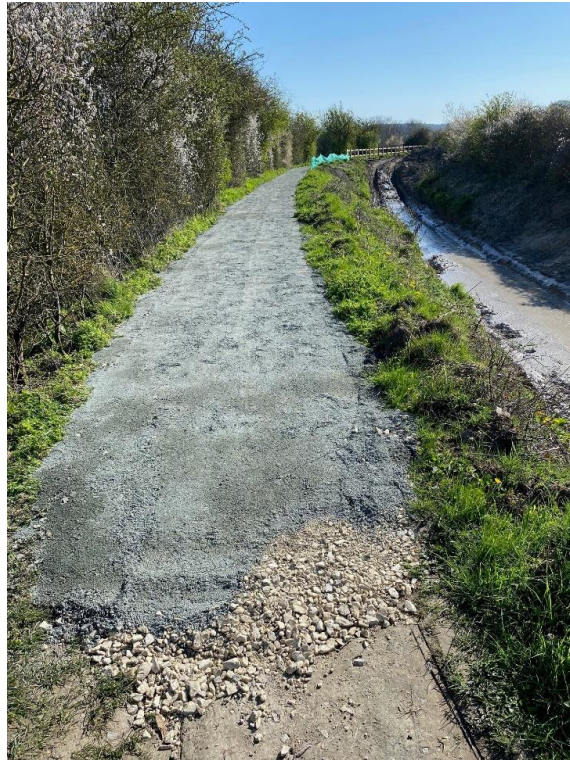
Towpath upgrade complete

The section of towpath was topped with Type 1 to full depth over the last 20m. a surface dressing of fine aggregate was placed, raked and compacted to complete the work.

In total 167m of towpath has been upgraded.

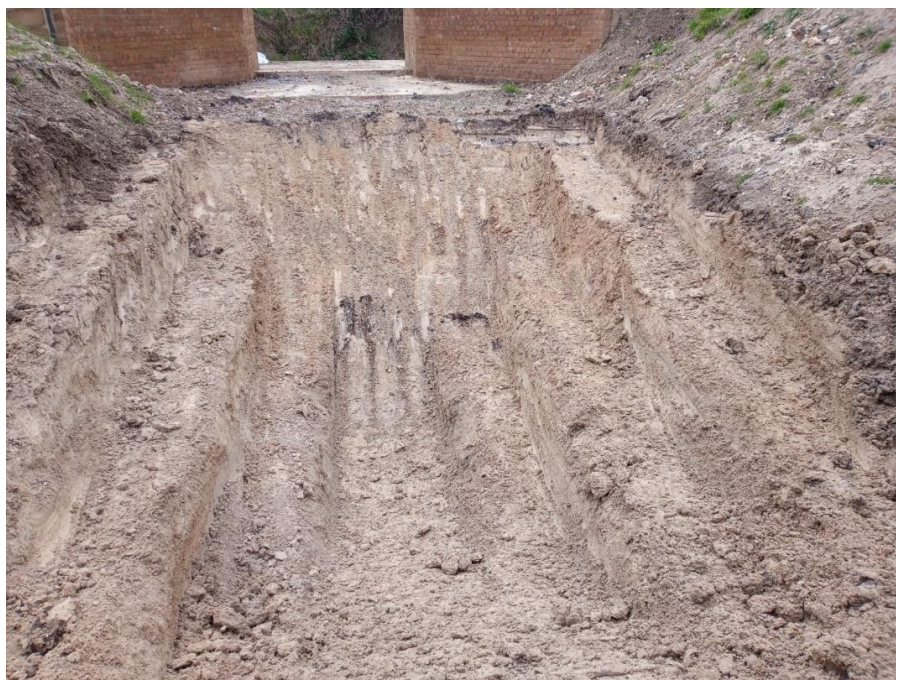
Excavation of terraces below the canal bed.

An excavation, 4.4m wide at the top and 2.5m at the bottom, terraced in 0.6m layers was excavated.

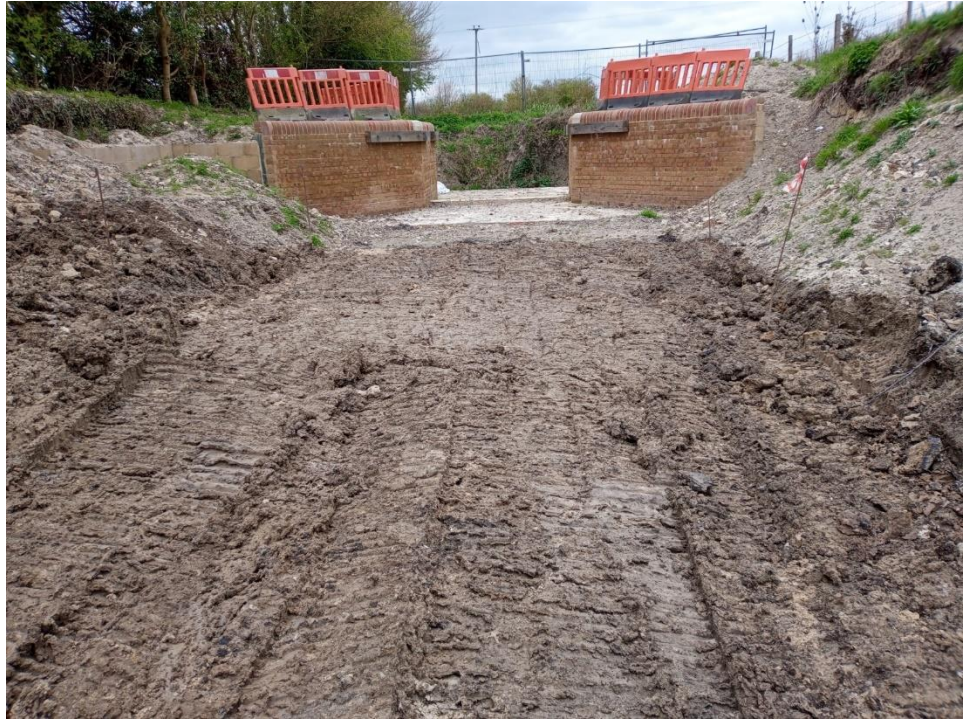
It was found that the contaminated spoil was too wet to compact adequately and will be left to consolidate before work is carried out.

Trial excavation backfilled and compacted.

The excavation was filled with contaminated spoil from the canal channel and compacted in 300mm layers.

An over-burden of spoil will be placed on this to ensure full consolidation prior to the next stage of the work in the area in 12 months time.
