Wendover Canal Trust – January 2024 Work Party Report

The one-week work party started on 12th January and took place at Wharf Road, Wendover and Little Tring. An extra day was held on 24th January.

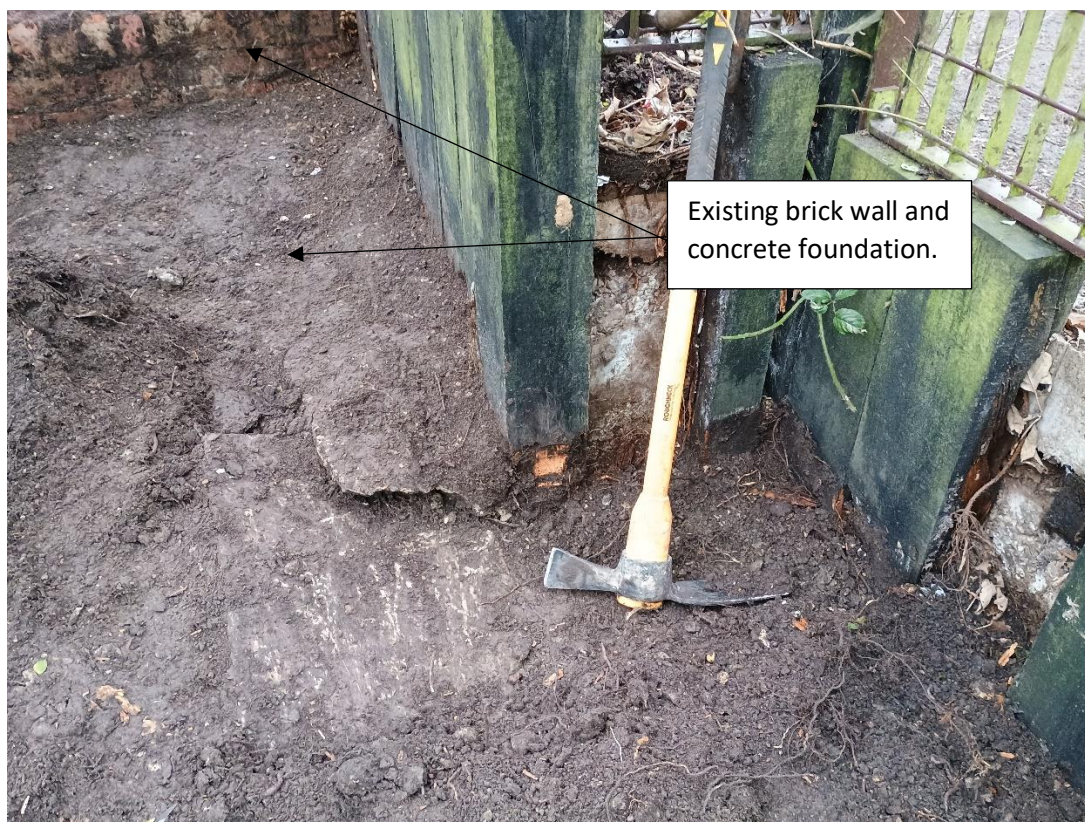
At the compound the vegetation was cleared from the line of the new railings and was taken to a licensed tip. On clearing the vegetation some existing brick and concrete foundations were uncovered. These can be incorporated into the new work. Amendments to the existing mesh fencing were made to allow the compound to remain secure during the work.

Existing foundations at Wharf Road.

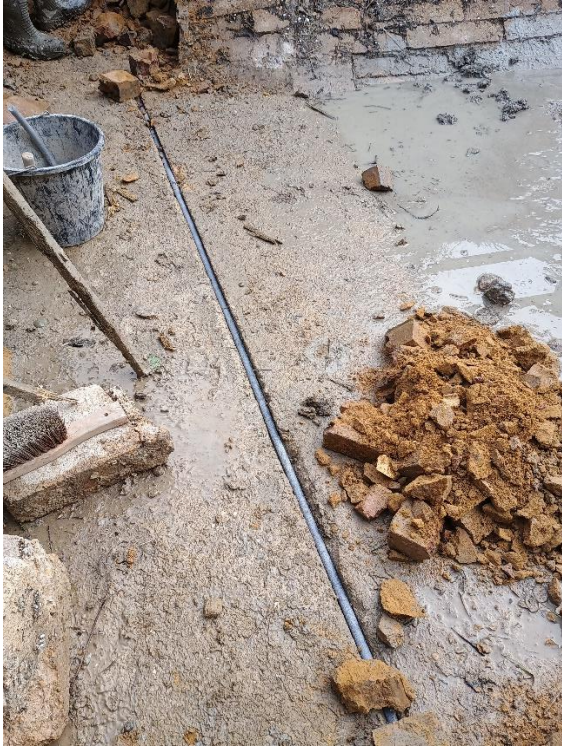
The timber in the joint in the bed was removed, revealing expansion foam in the joint. The joint was too wet to seal.

Joint across the bed of the canal.

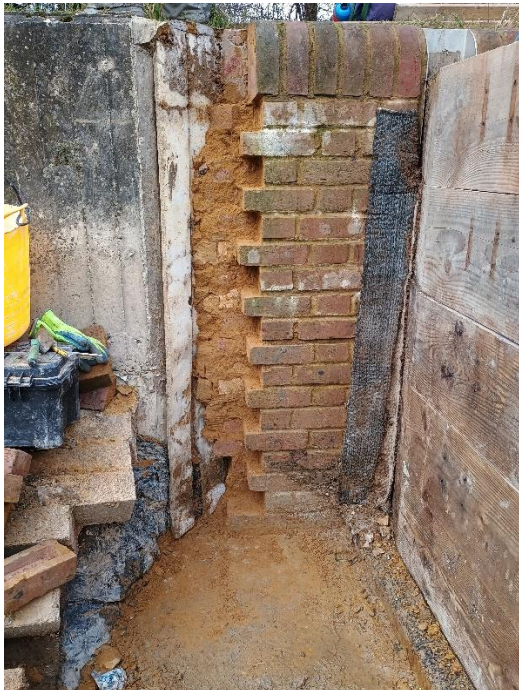
Towpath wall

The ends of the brick approach walls were taken down and the mortar cleaned out.

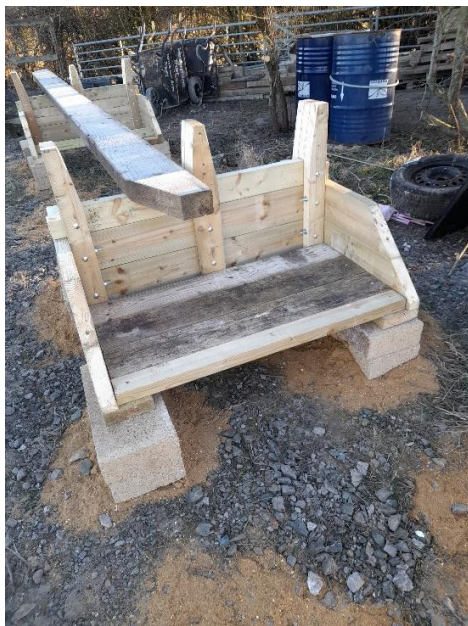
Stands have been made for the Bentomatic. These were set up next to the portaloo, but on reflection they need to be moved because movement of the 13t excavator to pick up the Bentomatic will lead to damage to the car park surface.

Stand with platform for the jig

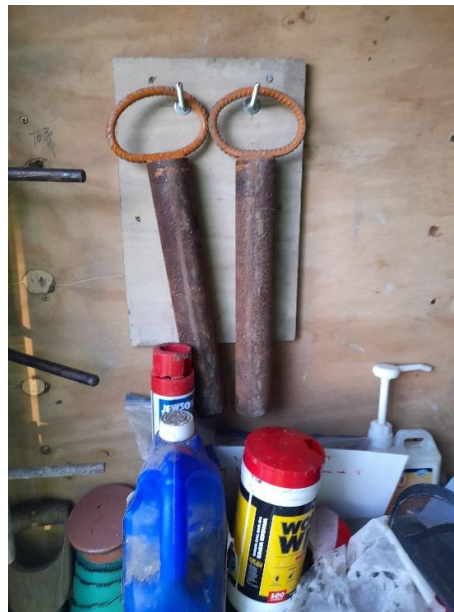
Pins for the Bentomatic in hut 3

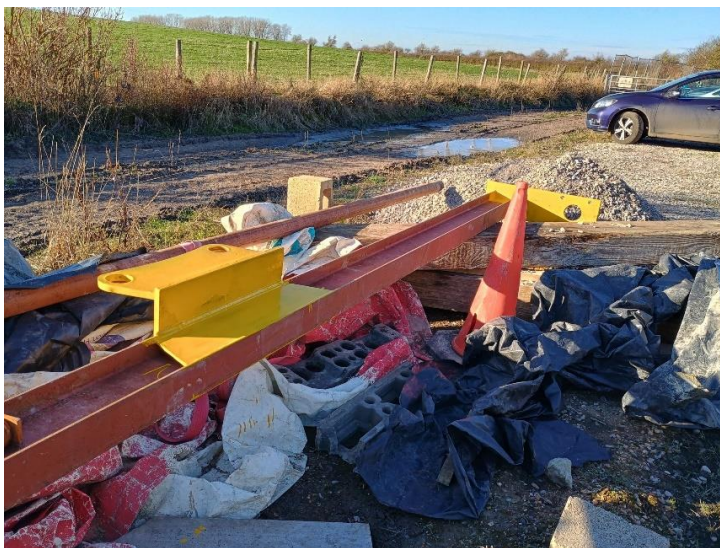
The Bentomatic was prepared and painted following the inspection last month.

Bentomatic, painted.

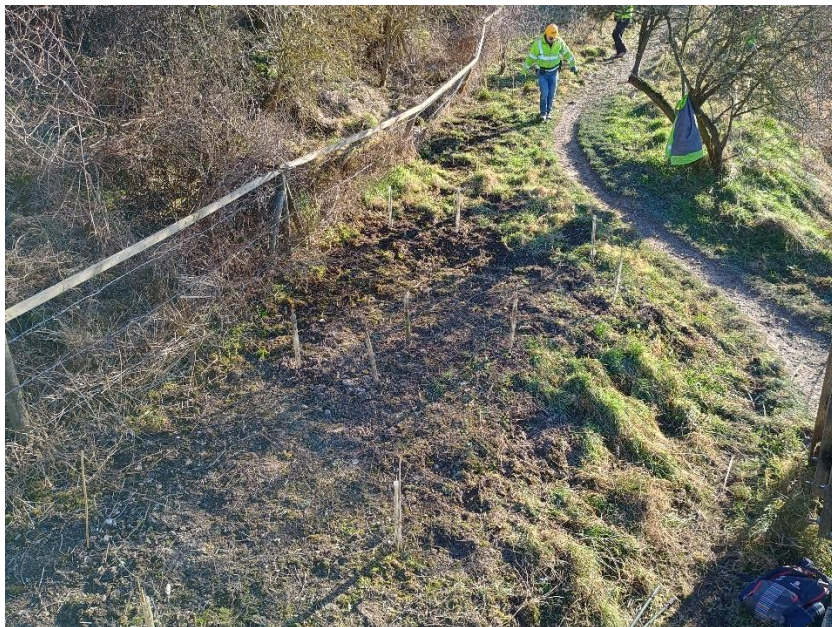
Bridge 4a cleared ready for trees.

The area at Bridge 4a was prepared ready for planting trees.

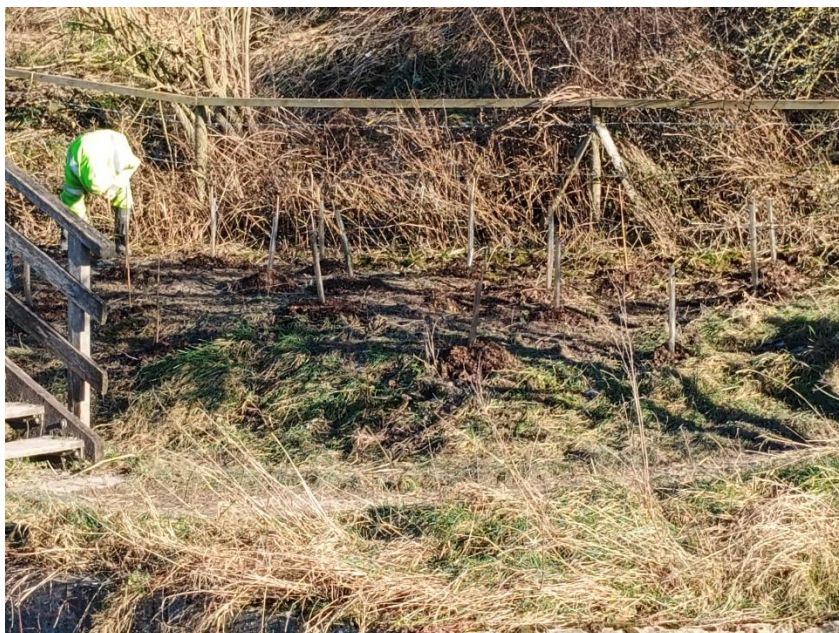
Trees planted at Bridge 4a

The weather was cold and the ground was frozen. Mulch was transported from Little Tring and placed around trees at Bridge 4a. later in the day the ground had thawed sufficiently to allow tree planting.

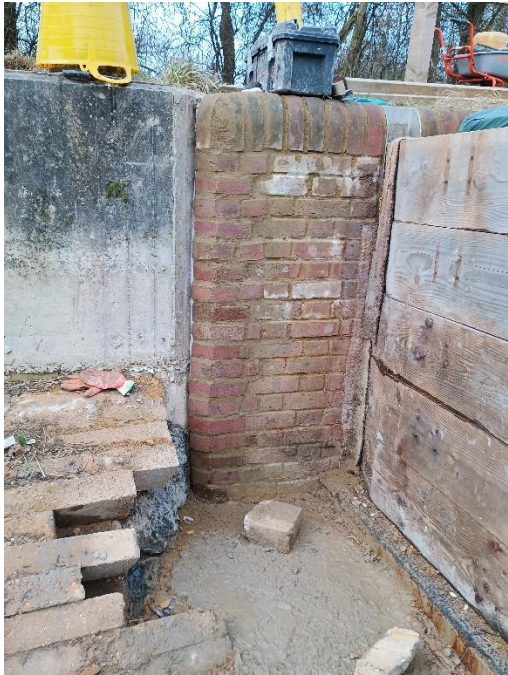
Towpath wall

Work was carried out at Bridge 4 on the extra day. Materials were moved and the ends of the approach walls were rebuilt.

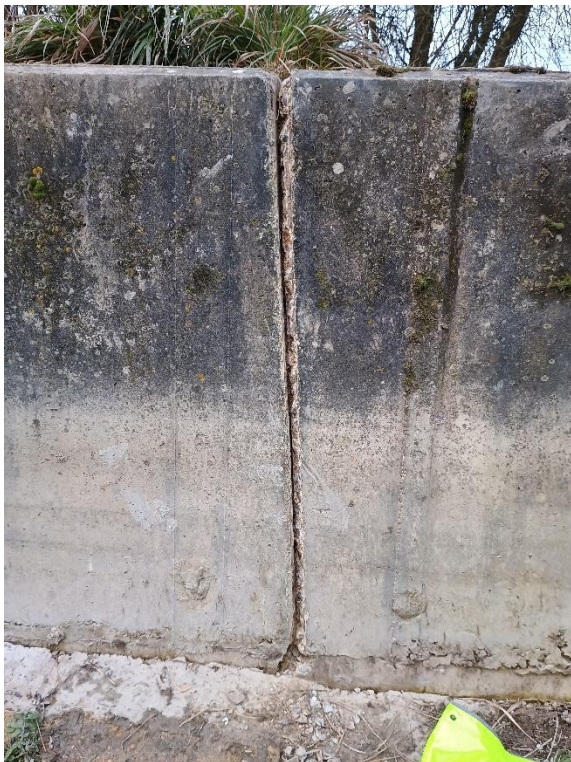
The sealant in the existing joints in the concrete bridge hole and mooring wall were inspected and were found to have failed. However, there is a water bar in these joints. The sealant will be broken out and replaced.

The sealant in the existing joints in the bridge hole and mooring wall was taken out and the joints prepared ready for sealant.

Joint in the bridge hole
